Detection and analysis of non-conformities in S355JR non-alloy structural steel

Franjo Kozina¹, Zdenka Zovko Brodarac¹, Luka Voloder² and Ivan Grgić³

This paper analyses the non-conformities found during the non-destructive testing of the main supporting columns of the steel infrastructure of the compressor station building. Compressor stations are critical facilities within the natural gas infrastructure and active elements of gas transportation networks. Their task is to pressurize natural gas to overcome pressure losses caused by friction, positive slopes and demand nodes. Their partial or complete failure can jeopardize gas transport.

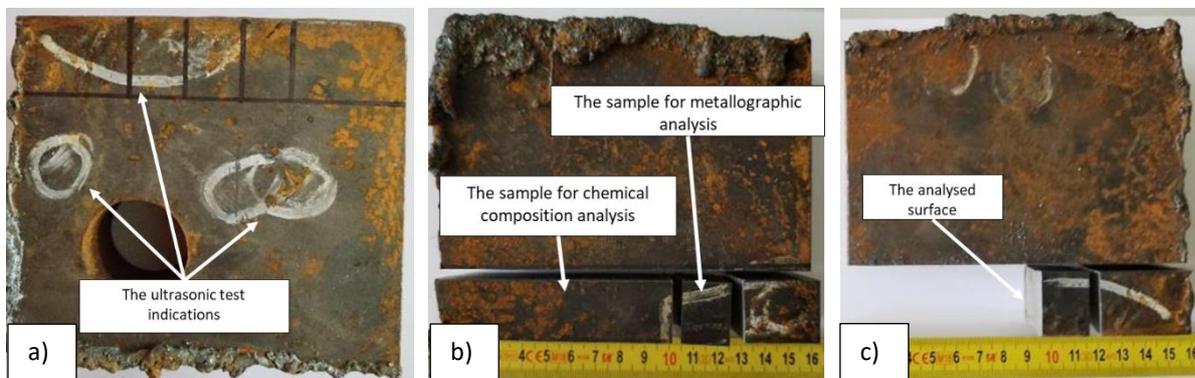
Figure 2. The sampling for additional tests: a) the ultrasonic test indications, b) chemical composition and metallographic analysis, c) the indicated surface for microstructural analysis

The sampling for the chemical composition and the metallographic analysis was based on the results of the ultrasonic testing. To determine the nature and cause of the non-conformities, samples for metallographic analysis were taken from the previously marked locations (Figure 2 a). To avoid the possible influence of flame cutting on the microstructure development, the samples were taken further away from the edge of the plate (Figure 2 b). The metallographic analysis was performed on the surface perpendicular to the rolling direction (Figure 2 c).

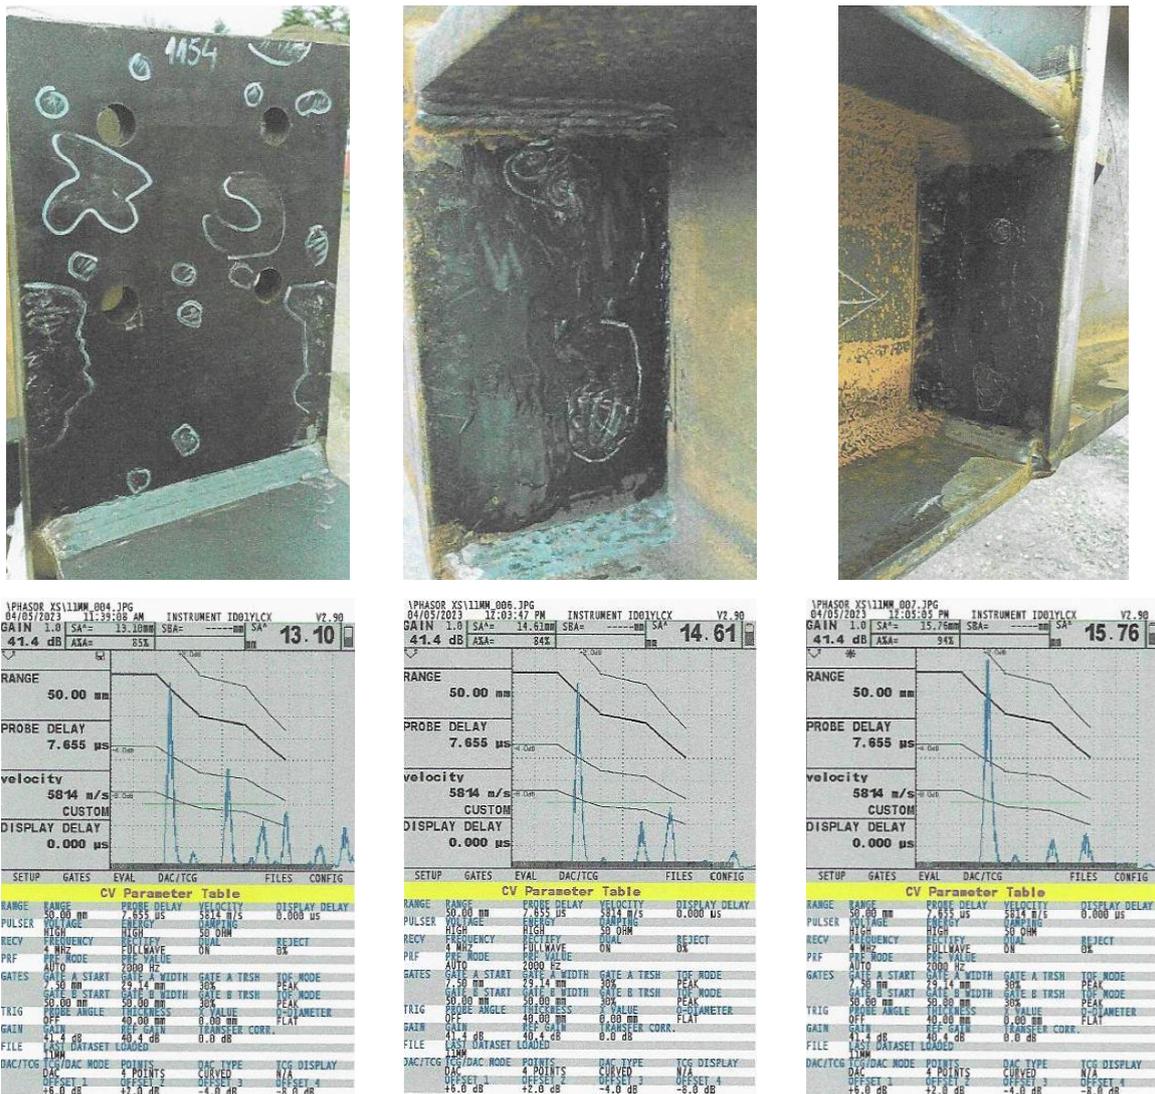
Figure 3. The results of ultrasonic tests

At a depth of 20 mm, the signs of the crocodile effect appear on the entire surface of the base material (Figure 3). The intensity of the crocodile effect signal is usually 50 % of the allowable limit, although the limit is occasionally exceeded. Other layered signals appear at different depths from 10 to 30 mm. The deviations in the signal were not detected in the welds. The appearance of the crocodile effect in steels is usually the result of thermomechanical processing of ingots, in which segregation of alloying elements and casting defects have occurred.

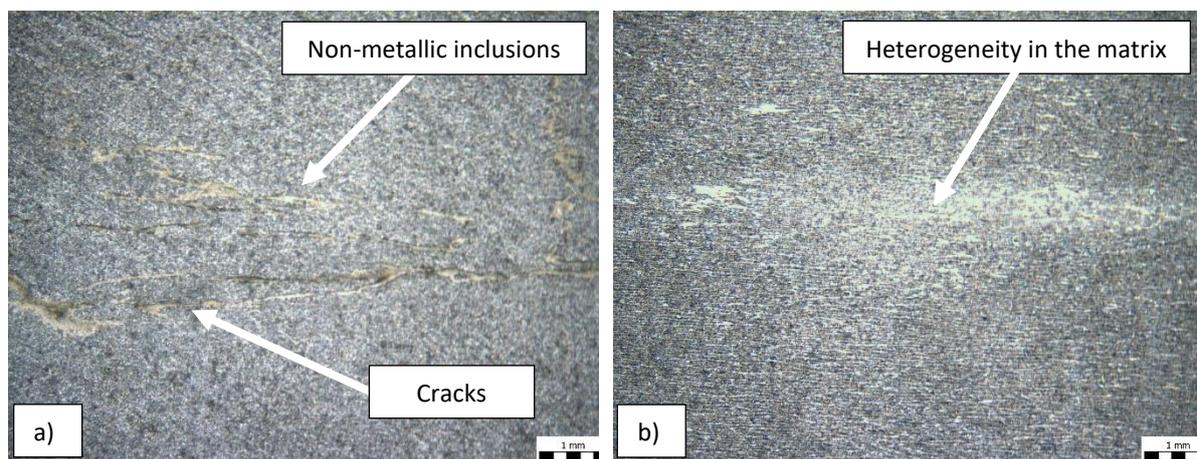
Figure 5. The macrostructure of the sample in etched condition at the magnification of 17.5 X: a) cracks and non-metallic inclusions, b) heterogeneity in the matrix

After standard metallographic preparation and etching, deviations in the analysed surface were observed at the depth of 14 and 20 mm (half of the cross-section of the plate). The results of the macrostructural analysis of the observed surface indicate the presence of non-metallic inclusions, cracks (Figure 5 a) and heterogeneities in the matrix structure (Figure 5 b). Figure 6 shows the microstructure of the sample in the polished and etched condition at different magnifications.

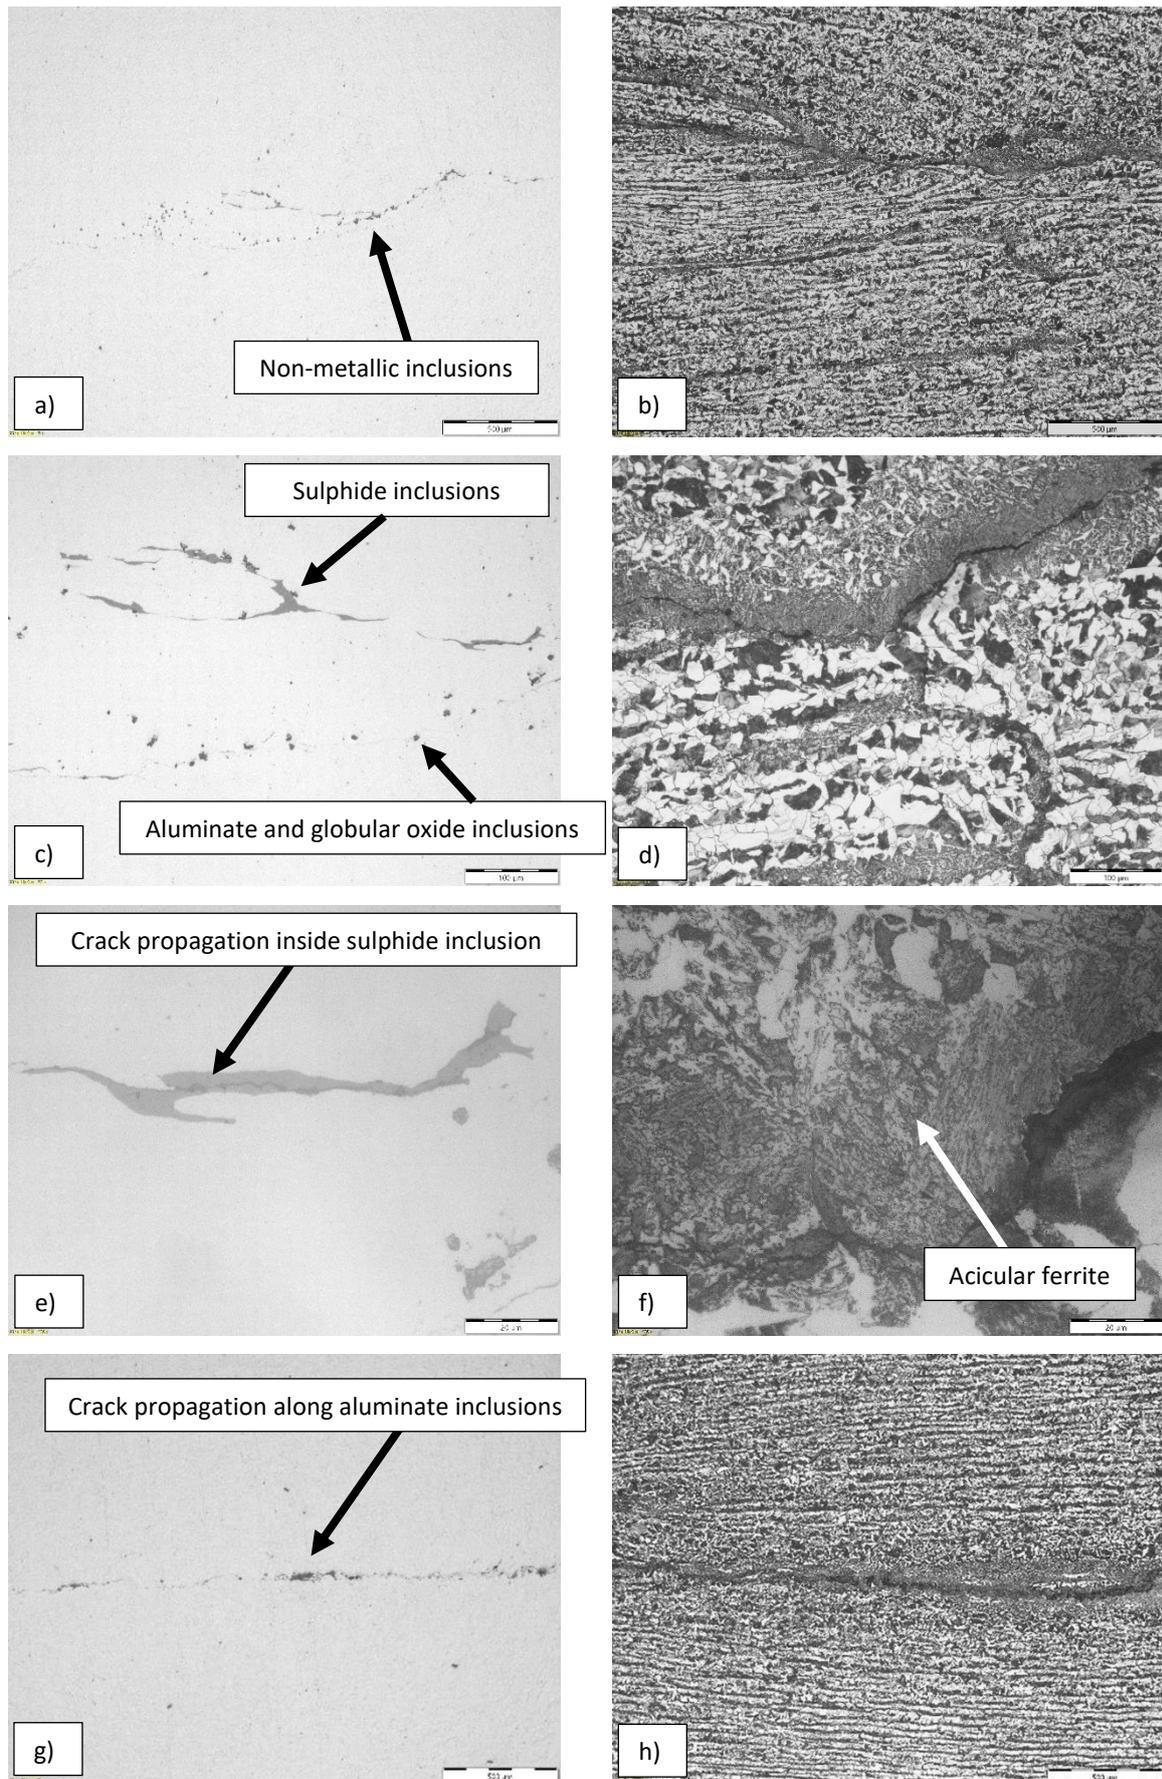
Figure 6. The microstructure of the sample in the polished and etched condition at different magnifications

Non-metallic inclusions of the sulphide type (Figure 6 a), aluminate and globular oxide type (Figure 6 c) as well as cracks (Figure 6 e) can be observed in the microstructure of the non-conformity area in the polished condition. Although it is not possible to clearly determine the location of crack initiation due to the sampling method, the propagation (advancement) of the cracks includes the non-metallic inclusions (Figure 6). Since sulphide inclusions have a lower hardness compared to the matrix, the crack appears inside the inclusion (Figure 6 d). On the other hand, aluminate and globular oxide inclusions have a higher hardness compared to the matrix, which is why crack propagation occurs along the inclusion/matrix interface (Figure 6 g).

The microstructure of the matrix is ferrite-pearlite with a pronounced rolling texture (Figure 6). As the steel was supplied in a normalized rolled condition, the presence of the rolling texture is not expected. In the area of non-conformity there is a deviation in the rolling texture orientation (Figure 6 b and d) and the appearance of mixed morphology ferrite (Figure 6 d and f). The ferrite has an acicular needle-like morphology (Figure 6 d and f). The presence of acicular ferrite indicates that normalization was performed at temperatures above the AC_3 line and an austenitic microstructure was achieved. The acicular ferrite nucleates heterogeneously on non-metallic inclusions within the austenitic grains. Higher magnification images indicate crack propagation along the sulphide and oxide inclusions during thermo-mechanical processing (Figure 7).

grain growth. Instead, localized heterogeneous nucleation of acicular ferrite occurred. Crack propagation occurred along the sulphide and oxide inclusions during thermo-mechanical processing. Although not defined in the standard, it was finally recommended to establish additional requirements for thermo-mechanical processing to control the microstructure of the final product, focussing on the type and content of non-metallic inclusions and the final allotropic modification and morphology of the solid solution of the iron matrix.

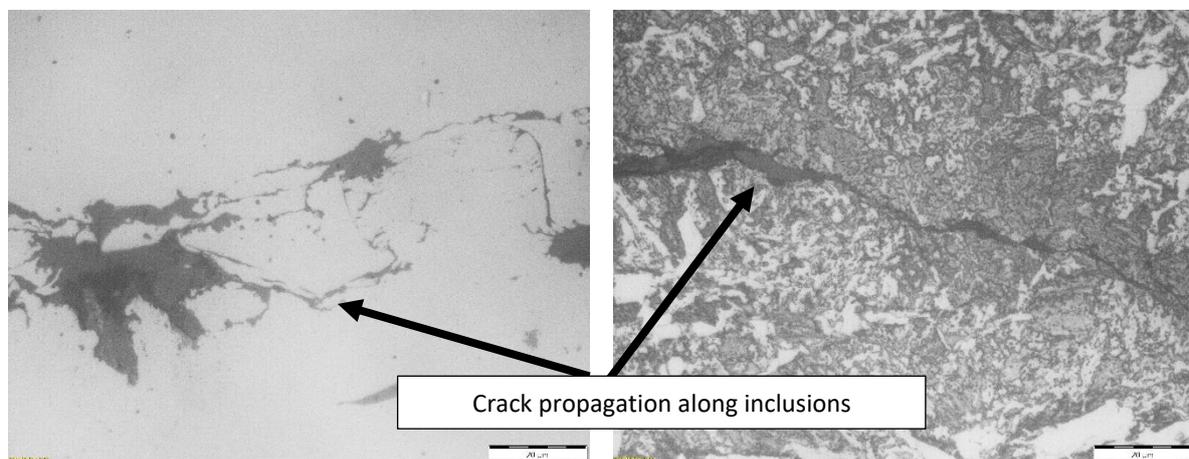
Figure 7. Involvement of non-metallic inclusions in crack propagation: a) polished, b) etched condition
