Detection and analysis of non-conformities in S355JR non-alloy structural steel

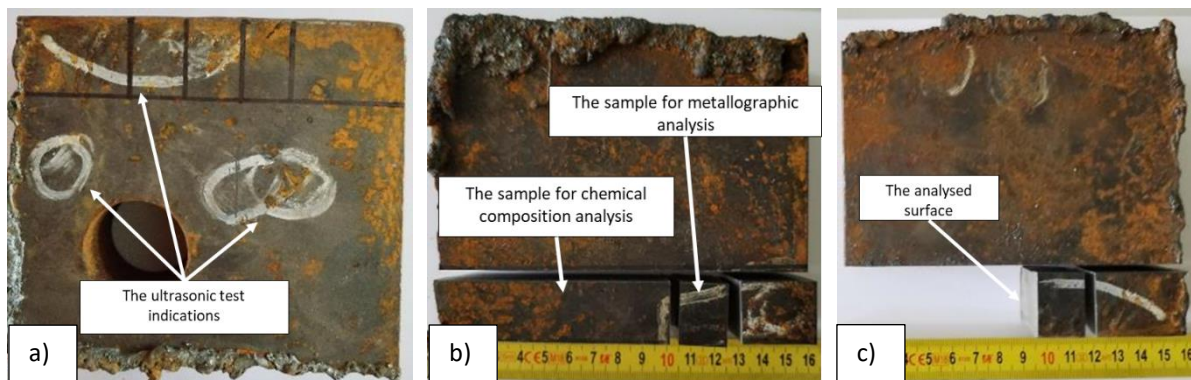
Figure 2. The sampling for additional tests: a) the ultrasonic test indications, b) chemical composition and metallographic analysis, c) the indicated surface for microstructural analysis

The sampling for the chemical composition and the metallographic analysis was based on the results of the ultrasonic testing. To determine the nature and cause of the non-conformities, samples for metallographic analysis were taken from the previously marked locations (Figure 2 a). To avoid the possible influence of flame cutting on the microstructure development, the samples were taken further away from the edge of the plate (Figure 2 b). The metallographic analysis was performed on the surface perpendicular to the rolling direction (Figure 2 c).

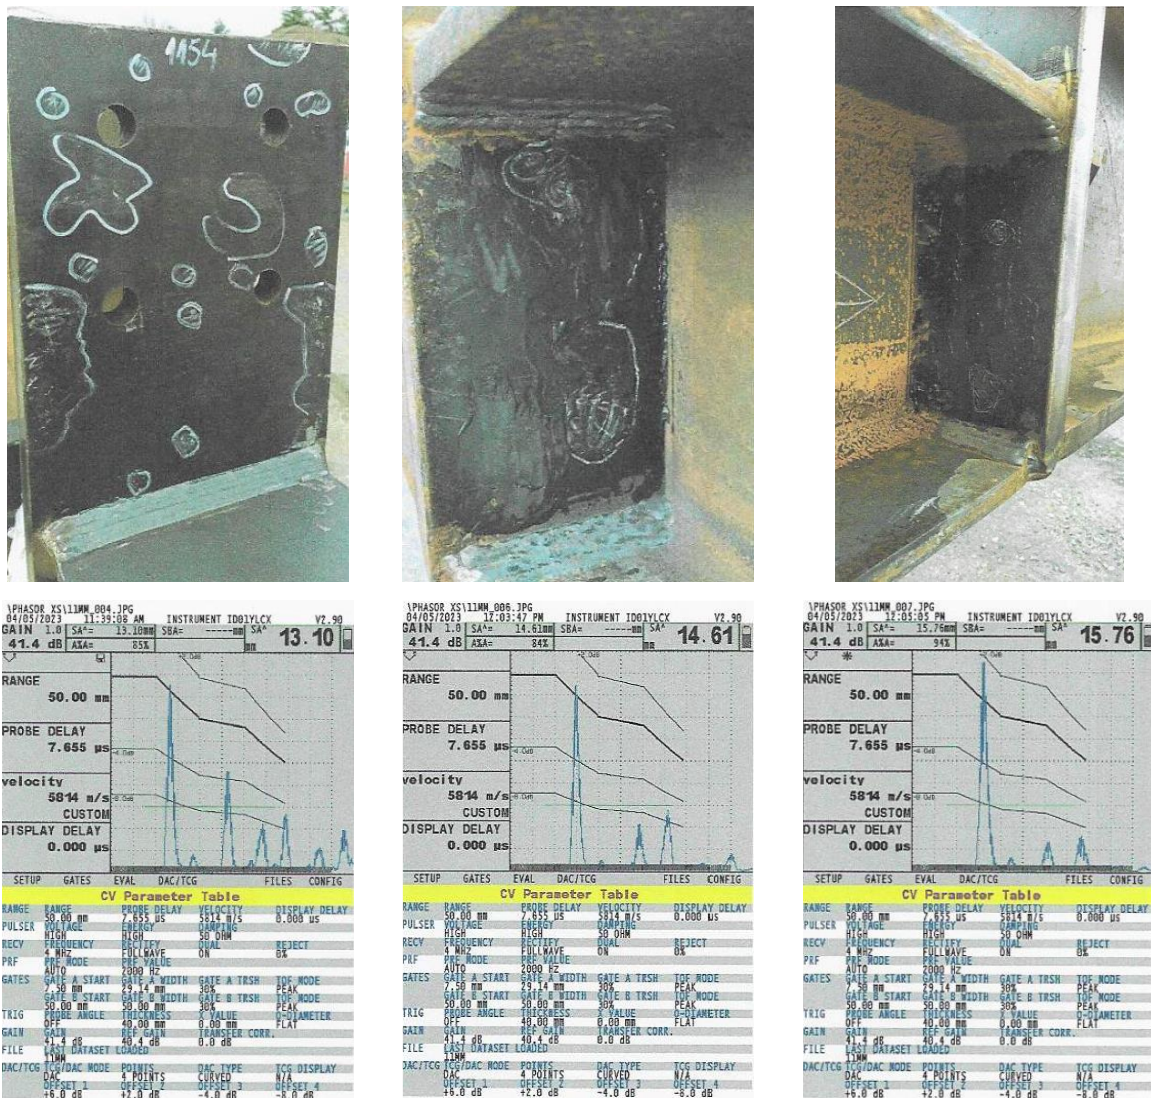
Figure 3. The results of ultrasonic tests

At a depth of 20 mm, the signs of the crocodile effect appear on the entire surface of the base material (Figure 3). The intensity of the crocodile effect signal is usually 50 % of the allowable limit, although the limit is occasionally exceeded. Other layered signals appear at different depths from 10 to 30 mm. The deviations in the signal were not detected in the welds. The appearance of the crocodile effect in steels is usually the result of thermomechanical processing of ingots, in which segregation of alloying elements and casting defects have occurred.

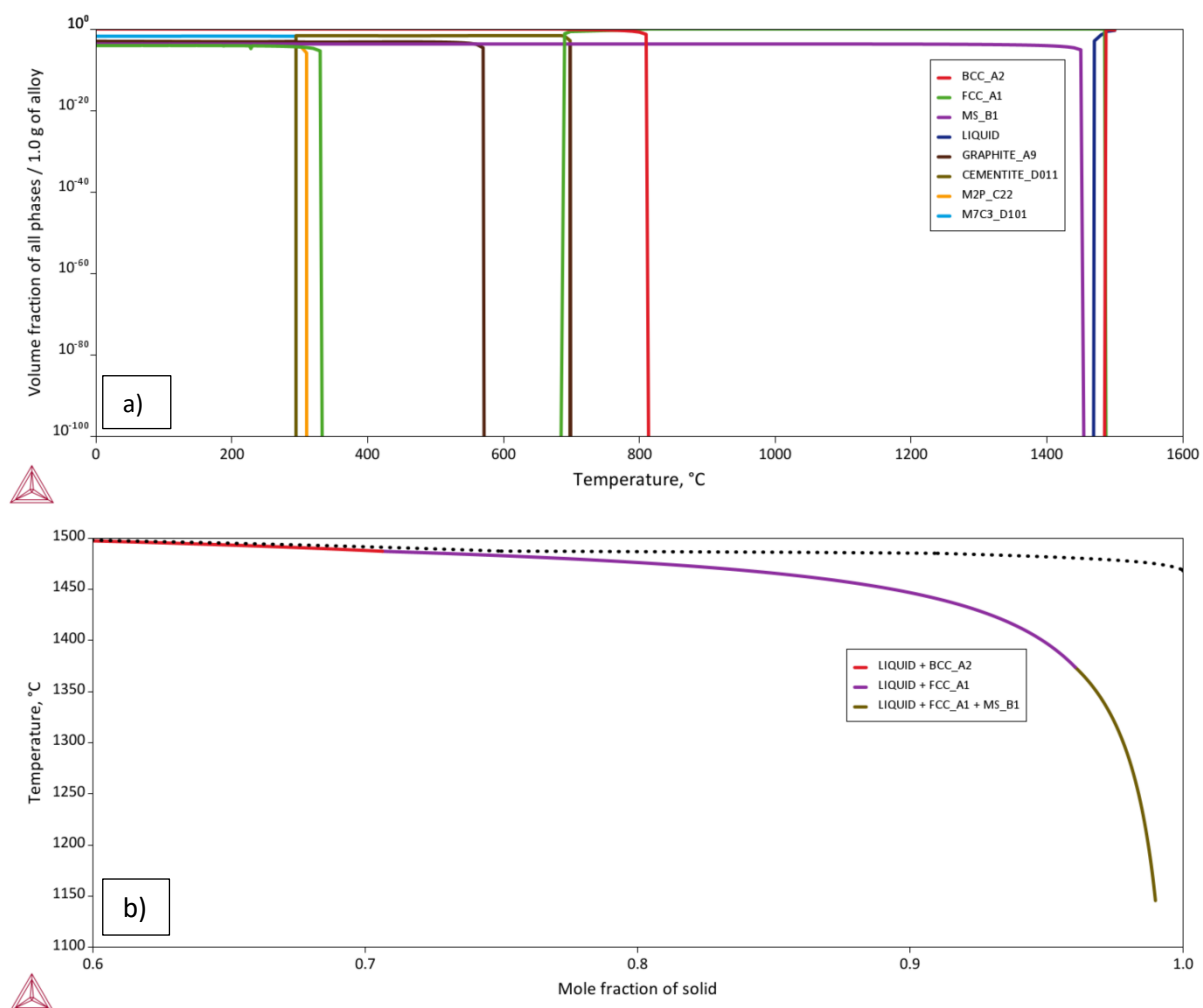
Figure 4. The results of Thermo-Calc calculations: a) equilibrium, b) non-equilibrium

In contrast to equilibrium solidification, the non-equilibrium solidification sequence takes place in the narrower temperature interval between 1514 °C and 1376.6 °C. The non-equilibrium solidification sequence recognizes the solidification of delta iron (δ -Fe), austenite (γ -Fe) and non-metallic MnS inclusions (Table 3). More importantly, the Scheil diagram shows a wide range between equilibrium and non-equilibrium solidification, indicating the possibility of segregation and the occurrence of casting defects during solidification.

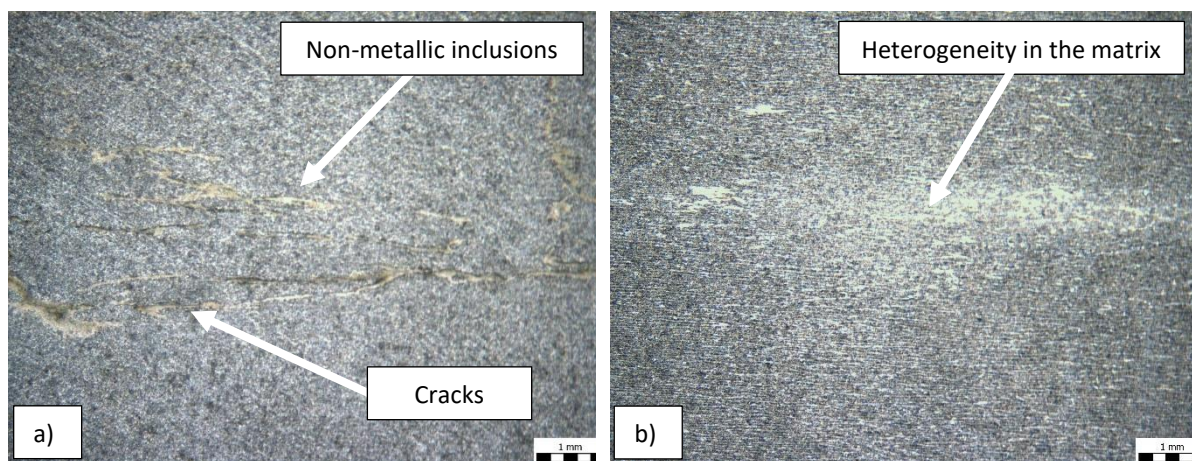
Figure 5. The macrostructure of the sample in etched condition at the magnification of 17.5 X: a) cracks and non-metallic inclusions, b) heterogeneity in the matrix

After standard metallographic preparation and etching, deviations in the analysed surface were observed at the depth of 14 and 20 mm (half of the cross-section of the plate). The results of the macrostructural analysis of the observed surface indicate the presence of non-metallic inclusions, cracks (Figure 5 a) and heterogeneities in the matrix structure (Figure 5 b). Figure 6 shows the microstructure of the sample in the polished and etched condition at different magnifications.

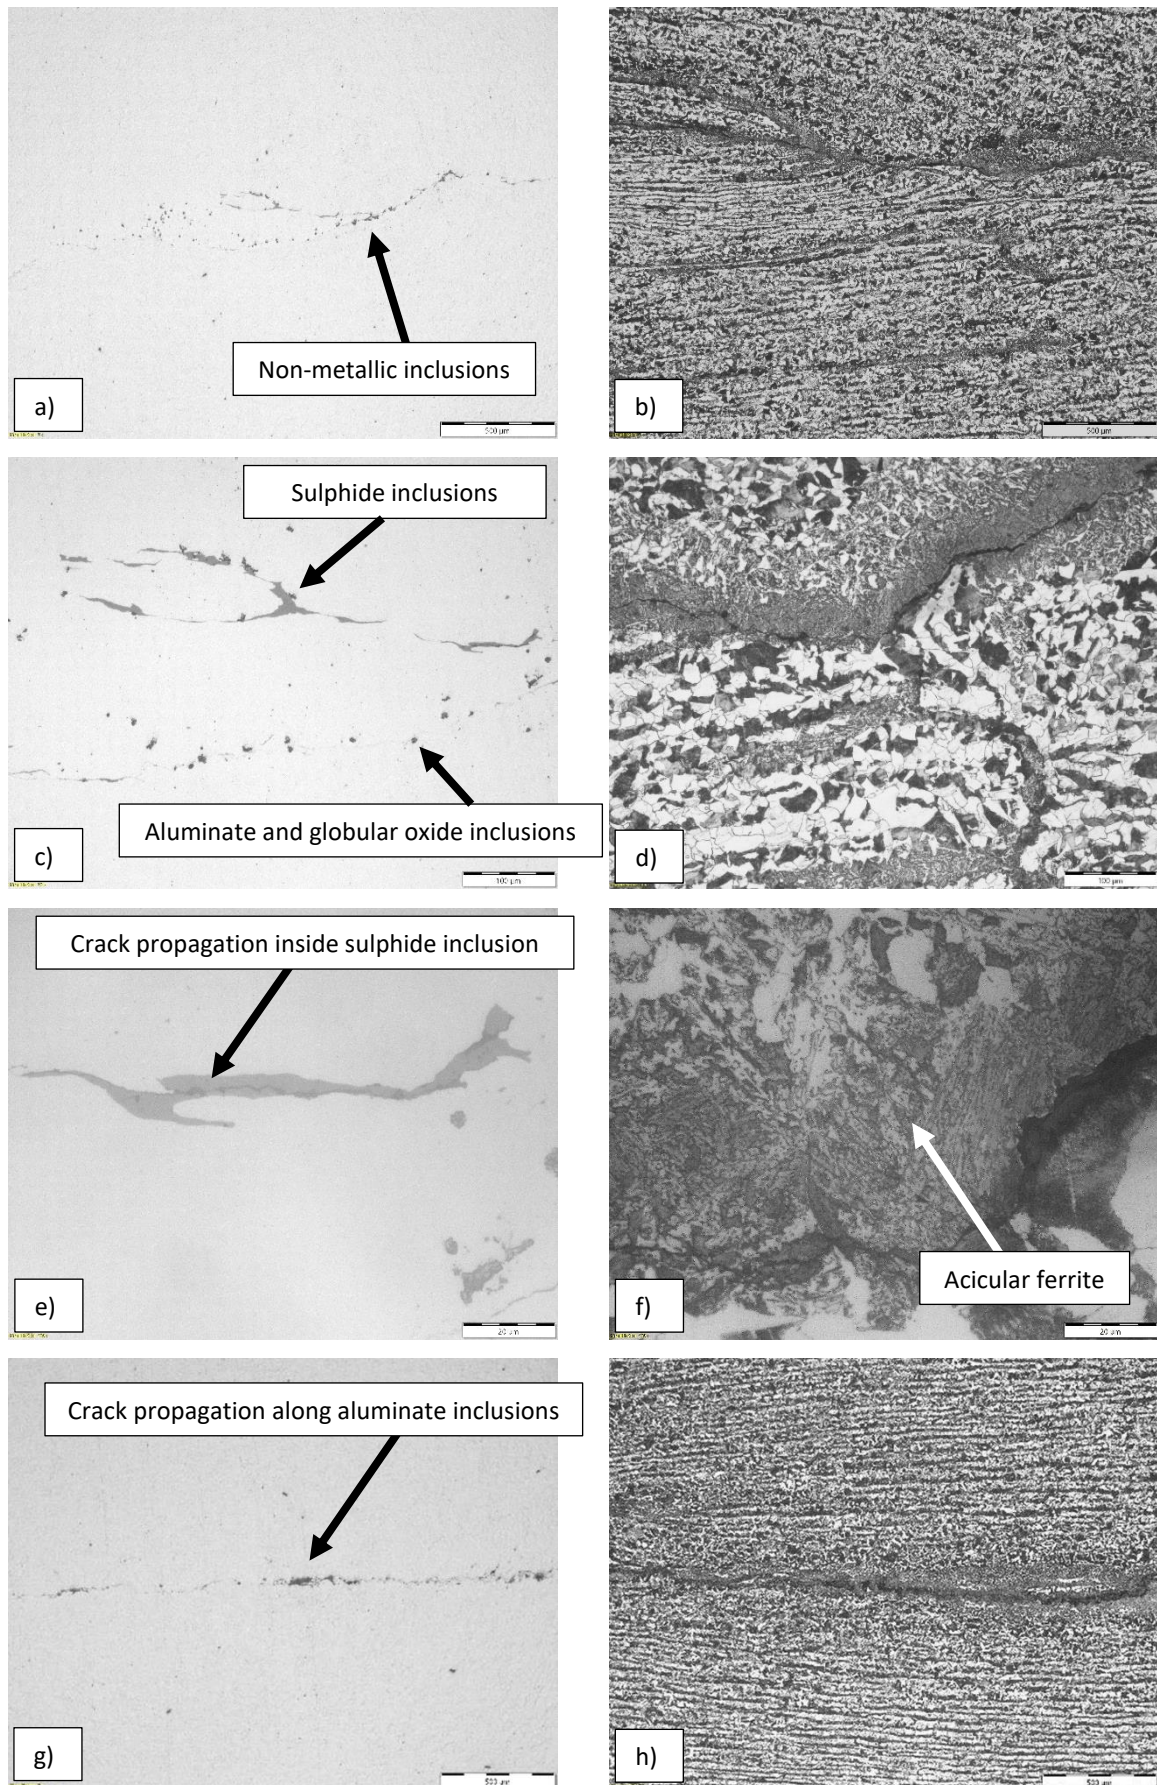
Figure 6. The microstructure of the sample in the polished and etched condition at different magnifications

Non-metallic inclusions of the sulphide type (Figure 6 a), aluminate and globular oxide type (Figure 6 c) as well as cracks (Figure 6 e) can be observed in the microstructure of the non-conformity area in the polished condition. Although it is not possible to clearly determine the location of crack initiation due to the sampling method, the propagation (advancement) of the cracks includes the non-metallic inclusions (Figure 6). Since sulphide inclusions have a lower hardness compared to the matrix, the crack appears inside the inclusion (Figure 6 d). On the other hand, aluminate and globular oxide inclusions have a higher hardness compared to the matrix, which is why crack propagation occurs along the inclusion/matrix interface (Figure 6 g).

The microstructure of the matrix is ferrite-pearlite with a pronounced rolling texture (Figure 6). As the steel was supplied in a normalized rolled condition, the presence of the rolling texture is not expected. In the area of non-conformity there is a deviation in the rolling texture orientation (Figure 6 b and d) and the appearance of mixed morphology ferrite (Figure 6 d and f). The ferrite has an acicular needle-like morphology (Figure 6 d and f). The presence of acicular ferrite indicates that normalization was performed at temperatures above the AC_3 line and an austenitic microstructure was achieved. The acicular ferrite nucleates heterogeneously on non-metallic inclusions within the austenitic grains. Higher magnification images indicate crack propagation along the sulphide and oxide inclusions during thermo-mechanical processing (Figure 7).

grain growth. Instead, localized heterogeneous nucleation of acicular ferrite occurred. Crack propagation occurred along the sulphide and oxide inclusions during thermo-mechanical processing. Although not defined in the standard, it was finally recommended to establish additional requirements for thermo-mechanical processing to control the microstructure of the final product, focussing on the type and content of non-metallic inclusions and the final allotropic modification and morphology of the solid solution of the iron matrix.

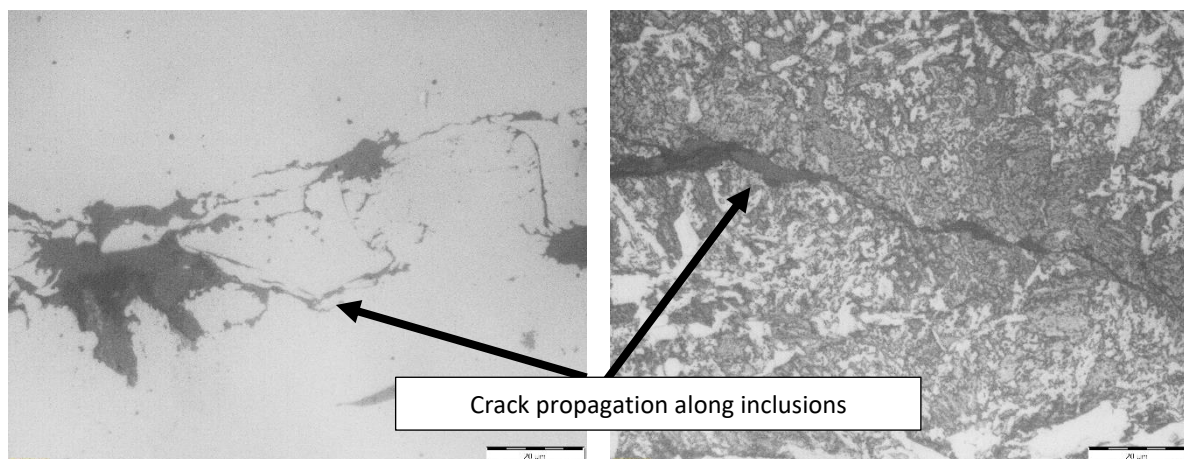
Figure 7. Involvement of non-metallic inclusions in crack propagation: a) polished, b) etched condition
