Influence of modification on microstructure degradation of AlSi12 alloy exposed to the corrosion environment

Source / Izvornik: **CONFERENCE PROCEEDINGS - METAL 2020, 2020, 994 - 999**

INFLUENCE OF MODIFICATION ON MICROSTRUCTURE DEGRADATION OF AISi12 ALLOY EXPOSED TO THE CORROSION ENVIRONMENT

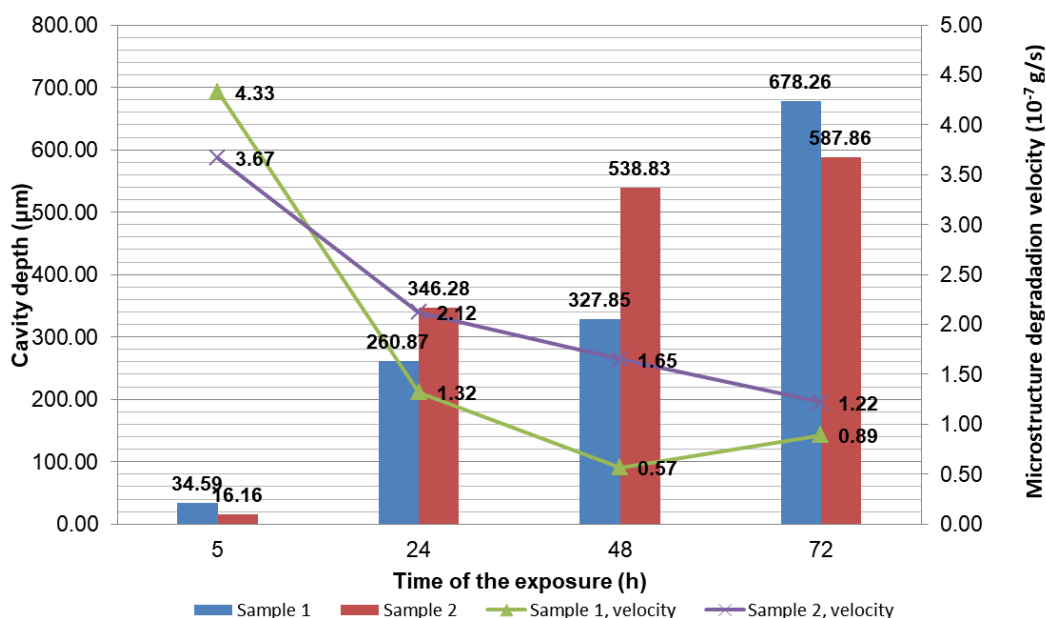
Figure 4 The average cavity depth and microstructure degradation rate

During the first 5 h the cavities with the average cavity size of 34.59 μm can be observed at the surface of the sample 1. The cavities form with the rate of $4.33 \cdot 10^{-7}$ g/s (**Figure 4**). The solution pH value decreases to 0.38 (**Table 2**). After 24 h the cavities with the average cavity size of 280.87 μm were formed with rate of $1.32 \cdot 10^{-7}$ g/s (**Figure 4**). The pH value of the solution increases to 0.53 (**Table 2**). After 48 h of exposure the microstructure degradation rate decreases to $0.57 \cdot 10^{-7}$ g/s while average cavity size increases to 328 μm (**Figure 4**). The solution pH value increases to 0.88 (**Table 2**). Towards the end of the exposure the microstructure degradation rate increases to $0.89 \cdot 10^{-7}$ g/s resulting in the cavity formation with average cavity size of 678 μm (**Figure 4**). The pH value increases to 1.14.

During the first 5 h the cavities with the average cavity size of 16 μm were formed at the surface of the sample 2. The cavities form with the rate of $3.67 \cdot 10^{-7}$ g/s (**Figure 4**). The solution pH value decreases to 0.35 (**Table 2**). After 24 h the cavities with the average cavity size of 346 μm were formed with rate of $2.12 \cdot 10^{-7}$ g/s (**Figure 4**). The pH value of the solution increases to 0.65 (**Table 2**). After 48 h of exposure the microstructure degradation rate decreases to $1.65 \cdot 10^{-7}$ g/s while average cavity size increases to 539 μm (**Figure 4**). The solution's pH value increases to 1.31 (**Table 2**). Towards the end of the exposure the microstructure degradation rate decreases to $1.22 \cdot 10^{-7}$ g/s resulting in the cavity formation with average cavity size of 588 μm (**Figure 4**). The pH value increases to 1.59.

The results of the measurements indicate the constant increase in average cavity size and pH value with the increase in corrosion exposure time. On the other hand the microstructure degradation rate decreases with the increase in exposure time. Compared to sample 2, the sample 1 shows more significant microstructure degradation and higher corrosion rate at 5 h and 72 h.

The average cavity depth and rate of the microstructure degradation are shown in **Figure 4**, while the changes in pH value are given in **Table 3**.
