INFLUENCE OF MODIFICATION ON MICROSTRUCTURE DEGRADATION OF AISi12 ALLOY EXPOSED TO THE CORROSION ENVIRONMENT

Franjo KOZINA, Zdenka ZOVKO BRODARAC

University of Zagreb Faculty of Metallurgy, Sisak, Croatia, EU, fkozin@simet.hr, zovko@simet.hr

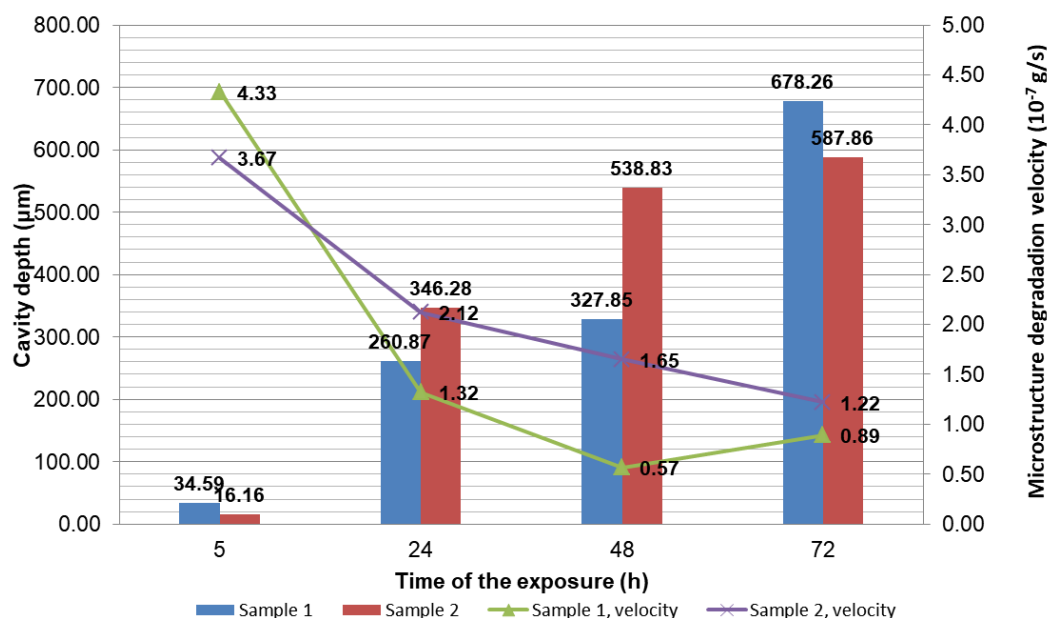
Figure 4 The average cavity depth and microstructure degradation rate

During the first 5 h the cavities with the average cavity size of 34.59 μm can be observed at the surface of the sample 1. The cavities form with the rate of $4.33 \cdot 10^{-7}$ g/s (**Figure 4**). The solution pH value decreases to 0.38 (**Table 2**). After 24 h the cavities with the average cavity size of 280.87 μm were formed with rate of $1.32 \cdot 10^{-7}$ g/s (**Figure 4**). The pH value of the solution increases to 0.53 (**Table 2**). After 48 h of exposure the microstructure degradation rate decreases to $0.57 \cdot 10^{-7}$ g/s while average cavity size increases to 328 μm (**Figure 4**). The solution pH value increases to 0.88 (**Table 2**). Towards the end of the exposure the microstructure degradation rate increases to $0.89 \cdot 10^{-7}$ g/s resulting in the cavity formation with average cavity size of 678 μm (**Figure 4**). The pH value increases to 1.14.

During the first 5 h the cavities with the average cavity size of 16 μm were formed at the surface of the sample 2. The cavities form with the rate of $3.67 \cdot 10^{-7}$ g/s (**Figure 4**). The solution pH value decreases to 0.35 (**Table 2**). After 24 h the cavities with the average cavity size of 346 μm were formed with rate of $2.12 \cdot 10^{-7}$ g/s (**Figure 4**). The pH value of the solution increases to 0.65 (**Table 2**). After 48 h of exposure the microstructure degradation rate decreases to $1.65 \cdot 10^{-7}$ g/s while average cavity size increases to 539 μm (**Figure 4**). The solution's pH value increases to 1.31 (**Table 2**). Towards the end of the exposure the microstructure degradation rate decreases to $1.22 \cdot 10^{-7}$ g/s resulting in the cavity formation with average cavity size of 588 μm (**Figure 4**). The pH value increases to 1.59.

The average cavity depth and rate of the microstructure degradation are shown in **Figure 4**, while the changes in pH value are given in **Table 3**.

The results of the measurements indicate the constant increase in average cavity size and pH value with the increase in corrosion exposure time. On the other hand the microstructure degradation rate decreases with the increase in exposure time. Compared to sample 2, the sample 1 shows more significant microstructure degradation and higher corrosion rate at 5 h and 72 h.
