Influence of modification on microstructure degradation of AlSi12 alloy exposed to the corrosion environment

INFLUENCE OF MODIFICATION ON MICROSTRUCTURE DEGRADATION OF AISi12 ALLOY EXPOSED TO THE CORROSION ENVIRONMENT

Franjo KOZINA, Zdenka ZOVKO BRODARAC

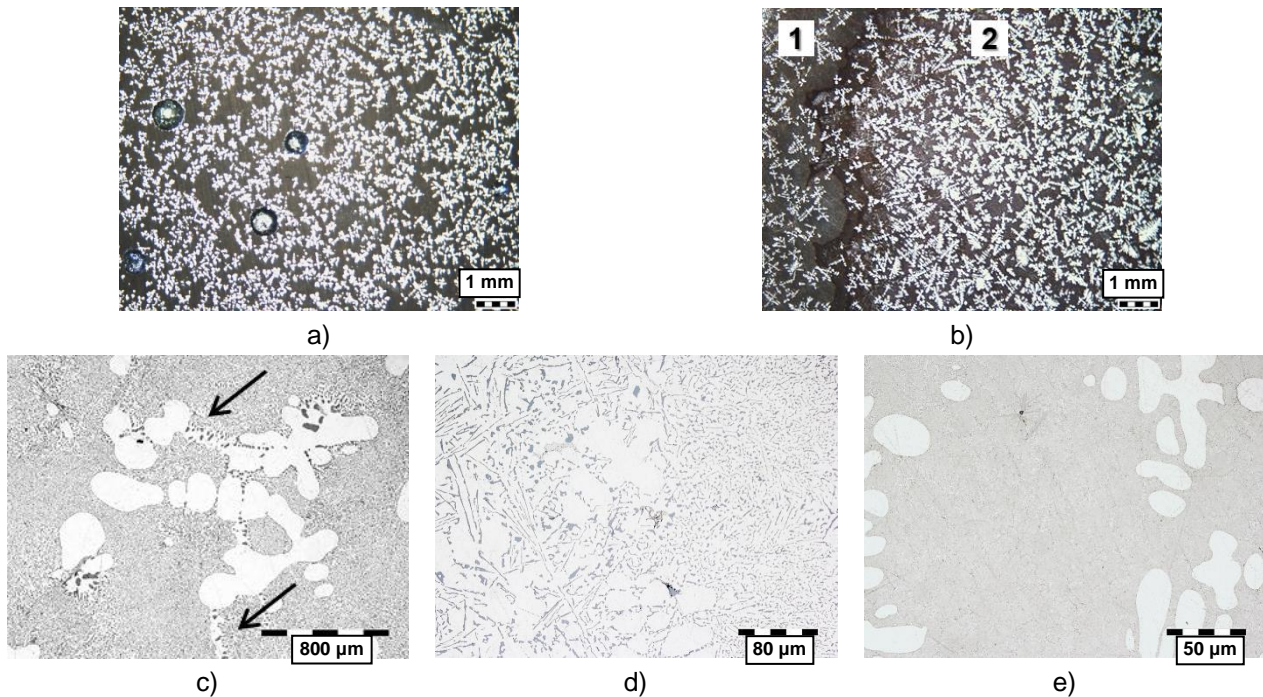
Figure 1 Micrographs of: a) macrostructure of the sample 1, b) macrostructure of the sample 2, c) microstructure of the sample 1, d) microstructure of the sample 2 in the area 1, e) microstructure of the sample 2 in the area 2

The macrostructure of the samples consists of a dendritic network of primary α_{Al} phase (**Figures 1 a, b**, bright areas) and interdendritic areas filled with eutectic ($\alpha_{Al} + \beta_{Si}$) (**Figures 1 a, b**, dark areas). The macrostructure of the sample 2 also reveals the presence of solid-liquid interface with growth direction from surface to the center of the sample. The quenching of the sample enabled formation of central zone (**Figure 1 b**, zone 2) and surface zone with average thickness of 2.69 mm (**Figure 1 b**, zone 1). In the sample 1 eutectic ($\alpha_{Al} + \beta_{Si}$) is fully modified with fine fibrous morphology (**Figure 1 a**). Due to the over modification with Na, the coarsening of the eutectic β_{Si} particles and the overgrowth of the α_{Al} matrix can be seen at the grain boundaries (**Figure 1 c**). The microstructural analysis of the sample 2 indicates the difference in eutectic ($\alpha_{Al} + \beta_{Si}$) morphology between the zones. The surface zone eutectic ($\alpha_{Al} + \beta_{Si}$) has lamellar morphology (**Figure 1 d**), while the eutectic ($\alpha_{Al} + \beta_{Si}$) in central zone is fully modified (**Figure 1 e**).

The macrostructure and microstructure of the samples are given in **Figure 1**.

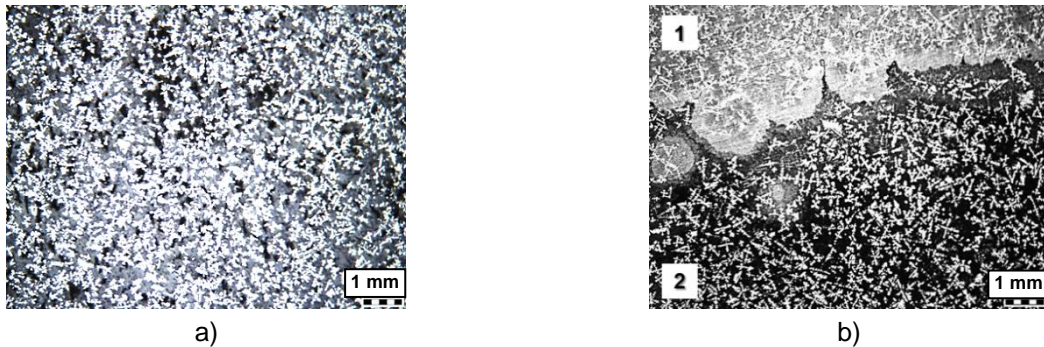
Figure 2 Macrostructure of samples at the magnification of 12.5 X:
a) Sample 1, b) Sample 2

During 48 h of exposure the microstructure degradation of sample 1 comprehended cavities formation in the interdendritic areas of primary α_{Al} phase (**Figure 2 a**, black areas). Exposure of sample 2 to the corrosive environment indicated quenched solid-liquid interface and small spherical colonies (**Figure 2 b**). The central zone of the sample 2 shows more significant microstructural degradation compared to the surface zone (**Figure 2 b**, black areas).

The example of the samples macrostructure after 48 h of exposure is given in **Figure 2**.

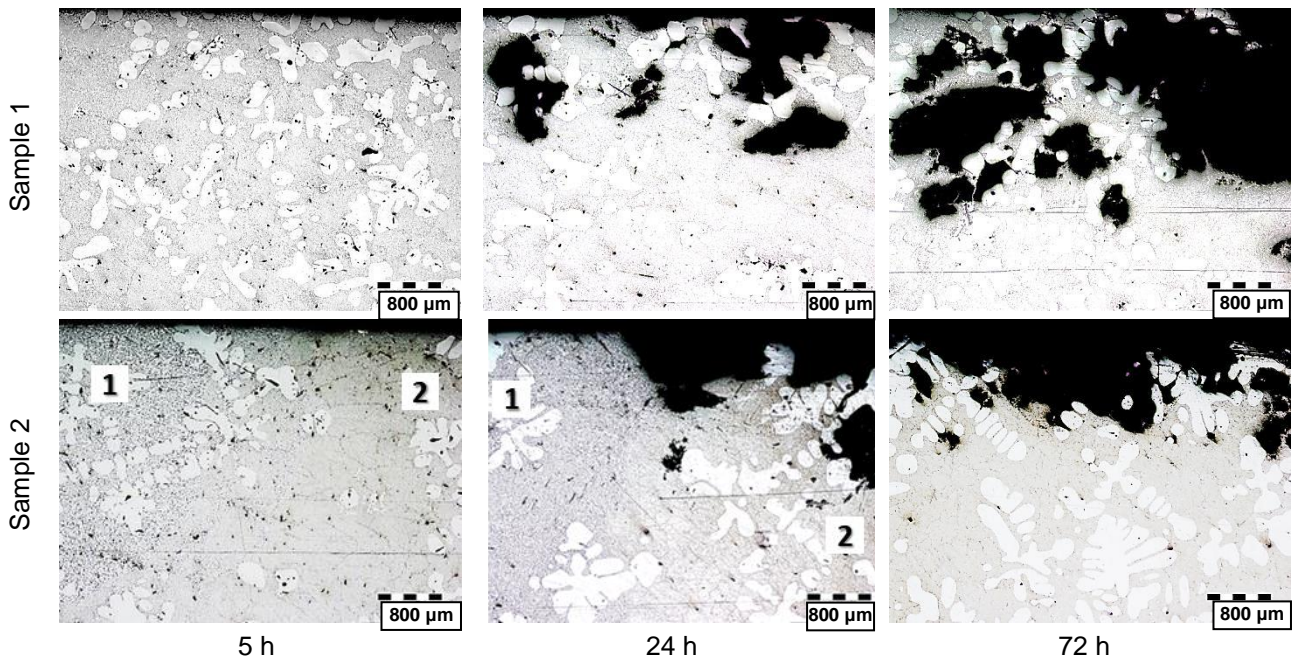
Figure 3 Microstructure of the samples after 5, 24, 72 h exposure to the corrosive environment

The cross-section of the sample 1, 5 h after the exposure shows negligible microstructural degradation. The cavities can be seen 24 and 72 h after the beginning of the testing. The cavities initiate at the exposed surface and progress deeper into the material affecting the eutectic ($\alpha_{Al} + \beta_{Si}$) located in the interdendritic network of primary α_{Al} phase (**Figure 3**, sample 1). The microstructure of the sample 2 after 5 h of exposure shows the lack of cavities at the solid-liquid interface. However, the small cavities forming at the surface of the sample can be found in central zone. The microstructure of the sample after 24 h of exposure shows presence of cavities at the solid-liquid interface progressing into the central zone with average size of eutectic β_{Si} particle 1.00 μm (**Table 2**). In next 72 h, the cavities progress deeper into the material affecting the modified eutectic

($\alpha_{Al} + \beta_{Si}$). The unmodified eutectic ($\alpha_{Al} + \beta_{Si}$) with average size of eutectic β_{Si} phase particle 5.33 μm (**Table 2**) is not significantly affected by the corrosion processes (**Figure 3**, sample 2).

The microstructure of the samples after 5, 24 and 72 h exposure is shown in **Figure 3**.

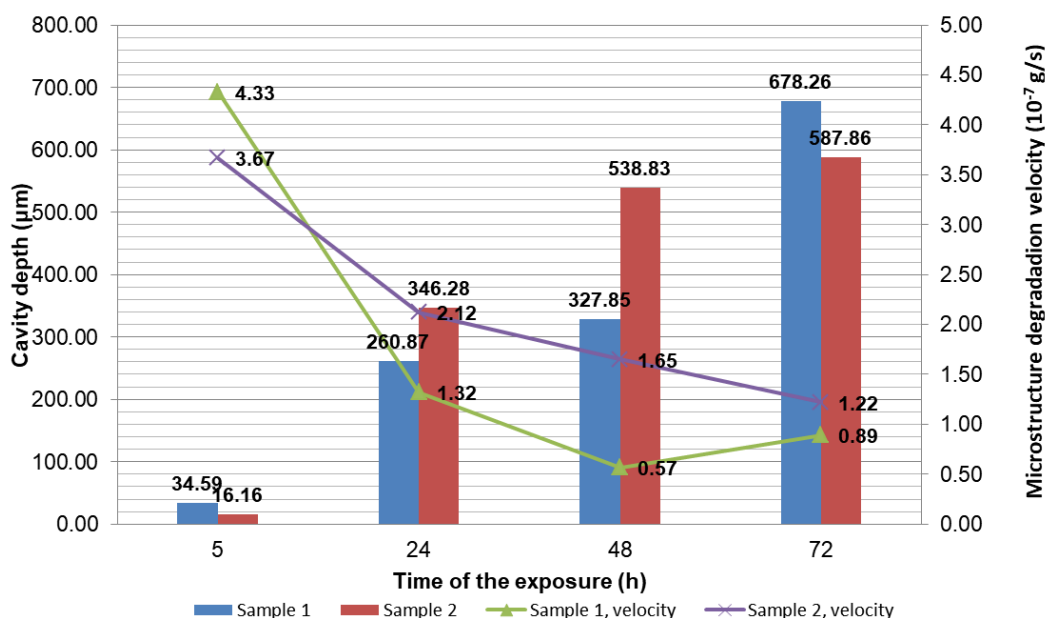
Figure 4 The average cavity depth and microstructure degradation rate

During the first 5 h the cavities with the average cavity size of 34.59 μm can be observed at the surface of the sample 1. The cavities form with the rate of $4.33 \cdot 10^{-7}$ g/s (**Figure 4**). The solution pH value decreases to 0.38 (**Table 2**). After 24 h the cavities with the average cavity size of 280.87 μm were formed with rate of $1.32 \cdot 10^{-7}$ g/s (**Figure 4**). The pH value of the solution increases to 0.53 (**Table 2**). After 48 h of exposure the microstructure degradation rate decreases to $0.57 \cdot 10^{-7}$ g/s while average cavity size increases to 328 μm (**Figure 4**). The solution pH value increases to 0.88 (**Table 2**). Towards the end of the exposure the microstructure degradation rate increases to $0.89 \cdot 10^{-7}$ g/s resulting in the cavity formation with average cavity size of 678 μm (**Figure 4**). The pH value increases to 1.14.

During the first 5 h the cavities with the average cavity size of 16 μm were formed at the surface of the sample 2. The cavities form with the rate of $3.67 \cdot 10^{-7}$ g/s (**Figure 4**). The solution pH value decreases to 0.35 (**Table 2**). After 24 h the cavities with the average cavity size of 346 μm were formed with rate of $2.12 \cdot 10^{-7}$ g/s (**Figure 4**). The pH value of the solution increases to 0.65 (**Table 2**). After 48 h of exposure the microstructure degradation rate decreases to $1.65 \cdot 10^{-7}$ g/s while average cavity size increases to 539 μm (**Figure 4**). The solution's pH value increases to 1.31 (**Table 2**). Towards the end of the exposure the microstructure degradation rate decreases to $1.22 \cdot 10^{-7}$ g/s resulting in the cavity formation with average cavity size of 588 μm (**Figure 4**). The pH value increases to 1.59.

The average cavity depth and rate of the microstructure degradation are shown in **Figure 4**, while the changes in pH value are given in **Table 3**.

The results of the measurements indicate the constant increase in average cavity size and pH value with the increase in corrosion exposure time. On the other hand the microstructure degradation rate decreases with the increase in exposure time. Compared to sample 2, the sample 1 shows more significant microstructure degradation and higher corrosion rate at 5 h and 72 h.
