INFLUENCE OF MODIFICATION ON MICROSTRUCTURE DEGRADATION OF AISi12 ALLOY EXPOSED TO THE CORROSION ENVIRONMENT

Franjo KOZINA, Zdenka ZOVKO BRODARAC

Abstract

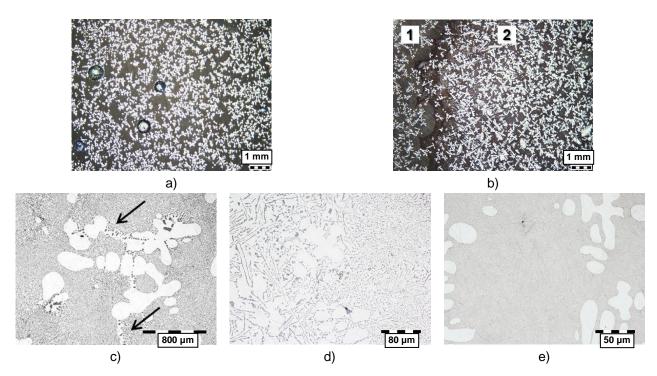
Figure 1 Micrographs of: a) macrostructure of the sample 1, b) macrostructure of the sample 2, c) microstructure of the sample 1, d) microstructure of the sample 2 in the area 1, e) microstructure of the sample 2 in the area 2

The macrostructure of the samples consists of a dendritic network of primary α_{Al} phase (**Figures 1 a, b**, bright areas) and interdendritic areas filled with eutectic ($\alpha_{Al} + \beta_{Si}$) (**Figures 1 a, b**, dark areas). The macrostructure of the sample 2 also reveals the presence of solid-liquid interface with growth direction from surface to the center of the sample. The quenching of the sample enabled formation of central zone (**Figure 1 b**, zone 2) and surface zone with average thickness of 2.69 mm (**Figure 1 b**, zone 1). In the sample 1 eutectic ($\alpha_{Al} + \beta_{Si}$) is fully modified with fine fibrous morphology (**Figure 1 a**). Due to the over modification with Na, the coarsening of the eutectic β_{Si} particles and the overgrowth of the α_{Al} matrix can be seen at the grain boundaries (**Figure 1 c**). The microstructural analysis of the sample 2 indicates the difference in eutectic ($\alpha_{Al} + \beta_{Si}$) morphology between the zones. The surface zone eutectic ($\alpha_{Al} + \beta_{Si}$) has lamellar morphology (**Figure 1 d**), while the eutectic ($\alpha_{Al} + \beta_{Si}$) in central zone is fully modified (**Figure 1 e**).

The macrostructure and microstructure of the samples are given in **Figure 1**.

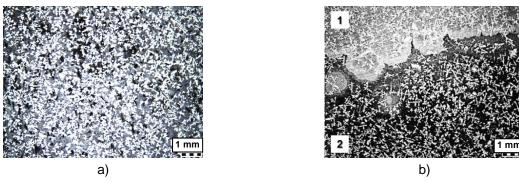
Figure 2 Macrostructure of samples at the magnification of 12.5 X: a) Sample 1, b) Sample 2

During 48 h of exposure the microstructure degradation of sample 1 comprehended cavities formation in the interdendritic areas of primary α_{Al} phase (**Figure 2 a**, black areas). Exposure of sample 2 to the corrosive environment indicated quenched solid-liquid interface and small spherical colonies (**Figure 2 b**). The central zone of the sample 2 shows more significant microstructural degradation compared to the surface zone (**Figure 2 b**, black areas).

The example of the samples macrostructure after 48 h of exposure is given in Figure 2.

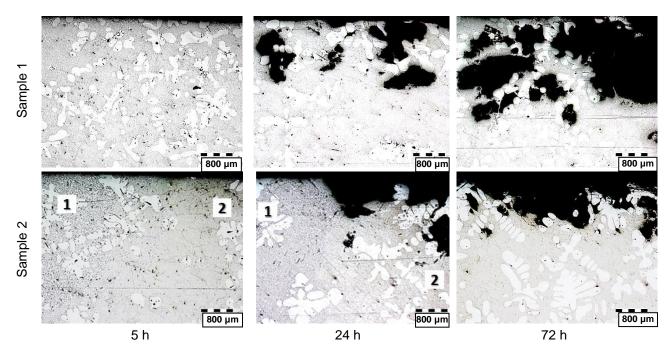
Figure 3 Microstructure of the samples after 5, 24, 72 h exposure to the corrosive environment

The cross-section of the sample 1, 5 h after the exposure shows negligible microstructural degradation. The cavities can be seen 24 and 72 h after the beginning of the testing. The cavities initiate at the exposed surface and progress deeper into the material affecting the eutectic $(\alpha_{Al} + \beta_{Si})$ located in the interdendritic network of primary α_{Al} phase (**Figure 3**, sample 1). The microstructure of the sample 2 after 5 h of exposure shows the lack of cavities at the solid-liquid interface. However, the small cavities forming at the surface of the sample can be found in central zone. The microstructure of the sample after 24 h of exposure shows presence of cavities at the solid-liquid interface progressing into the central zone with average size of eutectic β_{Si} particle 1.00 µm (**Table 2**). In next 72 h, the cavities progress deeper into the material affecting the modified eutectic

$(\alpha_{Al} + \beta_{Si})$. The unmodified eutectic $(\alpha_{Al} + \beta_{Si})$ with average size of eutectic β_{Si} phase particle 5.33 µm (**Table 2**) is not significantly affected by the corrosion processes (**Figure 3**, sample 2).

The microstructure of the samples after 5, 24 and 72 h exposure is shown in **Figure 3**.

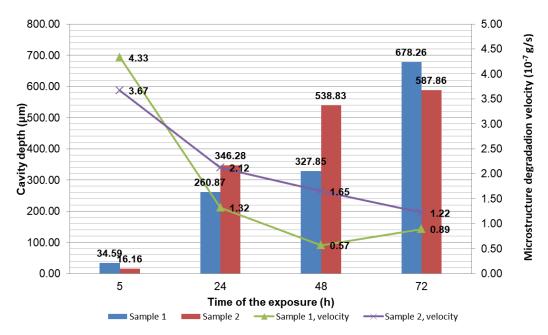
Figure 4 The average cavity depth and microstructure degradation rate

During the first 5 h the cavities with the average cavity size of 34.59 μ m can be observed at the surface of the sample 1. The cavities form with the rate of 4.33·10⁻⁷ g/s (**Figure 4**). The solution pH value decreases to 0.38 (**Table 2**). After 24 h the cavities with the average cavity size of 280.87 μ m were formed with rate of 1.32·10⁻⁷ g/s (**Figure 4**). The pH value of the solution increases to 0.53 (**Table 2**). After 48 h of exposure the microstructure degradation rate decreases to 0.57·10⁻⁷ g/s while average cavity size increases to 328 μ m (**Figure 4**). The solution pH value increases to 0.88 (**Table 2**). Towards the end of the exposure the microstructure degradation rate increases to 0.89·10⁻⁷ g/s resulting in the cavity formation with average cavity size of 678 μ m (**Figure 4**). The pH value increases to 1.14.

During the first 5 h the cavities with the average cavity size of 16 μ m were formed at the surface of the sample 2. The cavities form with the rate of $3.67 \cdot 10^{-7}$ g/s (**Figure 4**). The solution pH value decreases to 0.35 (**Table 2**). After 24 h the cavities with the average cavity size of 346 μ m were formed with rate of $2.12 \cdot 10^{-7}$ g/s (**Figure 4**). The pH value of the solution increases to 0.65 (**Table 2**). After 48 h of exposure the microstructure degradation rate decreases to $1.65 \cdot 10^{-7}$ g/s while average cavity size increases to 539 μ m (**Figure 4**). The solution's pH value increases to 1.31 (**Table 2**). Towards the end of the exposure the microstructure degradation rate decreases to $1.22 \cdot 10^{-7}$ g/s resulting in the cavity formation with average cavity size of 588 μ m (**Figure 4**). The pH value increases to 1.59.

The average cavity depth and rate of the microstructure degradation are shown in **Figure 4**, while the changes in pH value are given in **Table 3**.

The results of the measurements indicate the constant increase in average cavity size and pH value with the increase in corrosion exposure time. On the other hand the microstructure degradation rate decreases with the increase in exposure time. Compared to sample 2, the sample 1 shows more significant microstructure degradation and higher corrosion rate at 5 h and 72 h.
