INFLUENCE OF MODIFICATION ON MICROSTRUCTURE DEGRADATION OF AISi12 ALLOY EXPOSED TO THE CORROSION ENVIRONMENT

Franjo KOZINA, Zdenka ZOVKO BRODARAC

University of Zagreb Faculty of Metallurgy, Sisak, Croatia, EU, fkozin@simet.hr, zovko@simet.hr

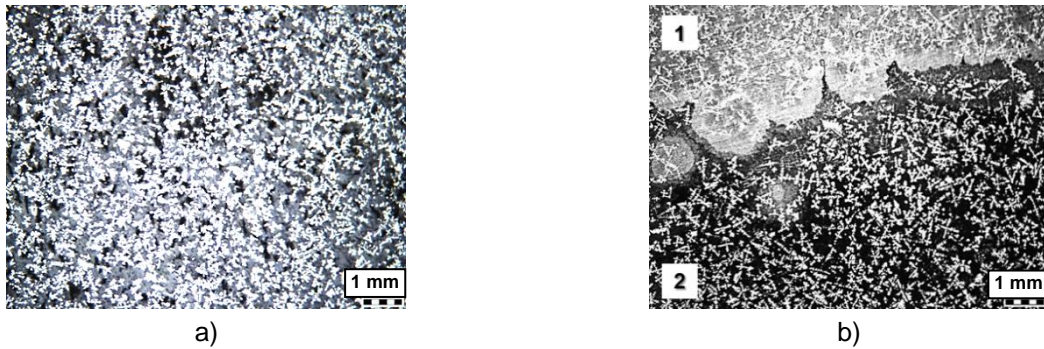
Figure 2 Macrostructure of samples at the magnification of 12.5 X:
a) Sample 1, b) Sample 2

During 48 h of exposure the microstructure degradation of sample 1 comprehended cavities formation in the interdendritic areas of primary α_{Al} phase (**Figure 2 a**, black areas). Exposure of sample 2 to the corrosive environment indicated quenched solid-liquid interface and small spherical colonies (**Figure 2 b**). The central zone of the sample 2 shows more significant microstructural degradation compared to the surface zone (**Figure 2 b**, black areas).

The example of the samples macrostructure after 48 h of exposure is given in **Figure 2**.
