# Influence of medium on corrosion and microstructural properties of HTCS-130 tool steel for hot work

*Source / Izvornik:* **18th International Foundrymen Conference Coexistence of material science and sustainable technology in economic growth, 2019, 188 - 205**

### INFLUENCE OF MEDIUM ON CORROSION AND MICROSTRUCTURAL PROPERTIES OF HTCS-130 TOOL STEEL FOR HOT WORK

Original scientific paper

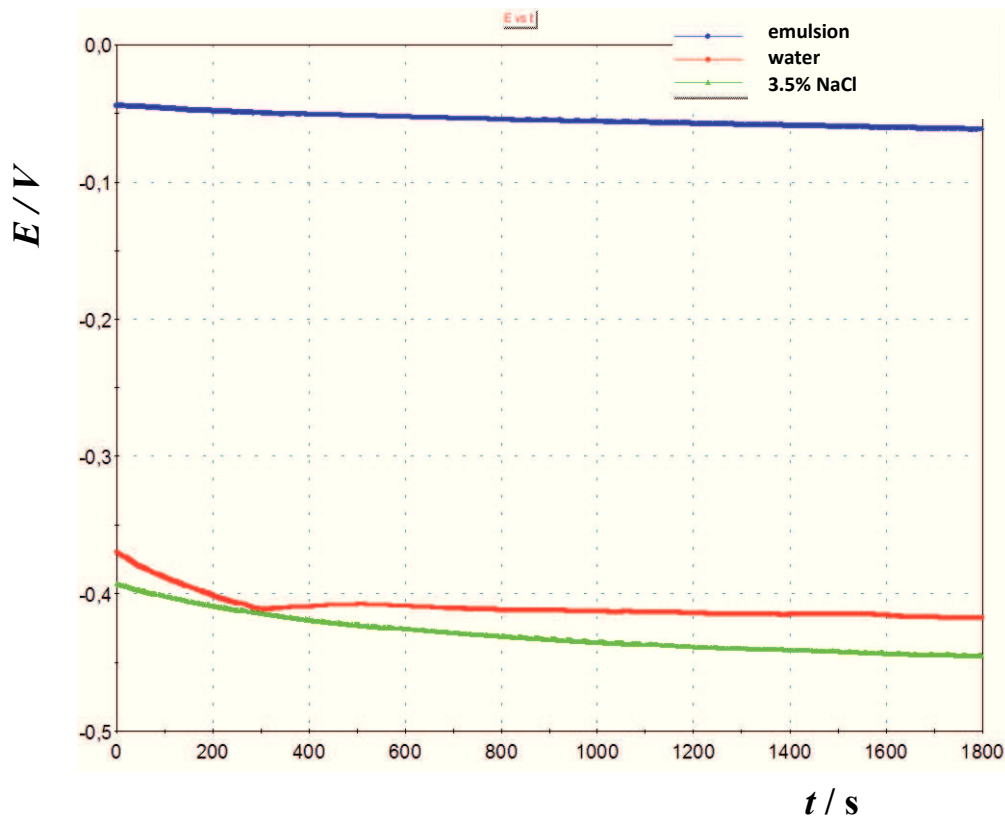
Figure 1. Time dependance of open circuit potential for HCTS-130 tool steel in medium of Lenox Band-Ade emulsion, water and 3.5% NaCl

From Figure 1 it is apparent that the sample tested in the selected media (Lenox Band-Ade emulsion, water, 3.5% NaCl) rapidly achieves its stationary potential, i.e. open circuit potential. In water and medium of 3.5% NaCl, the potentials are shifted to negative values indicating the presence of corrosion or instability of the electrode, so that the sample dissolves. In the Lenox Band-Ade emulsion medium, the potential is shifted to positive values, meaning the electrode is stable. For the stability of the electrodes in the emulsion, the inhibitor contained in the emulsion is partly responsible, because its task is to slow down the corrosion process.

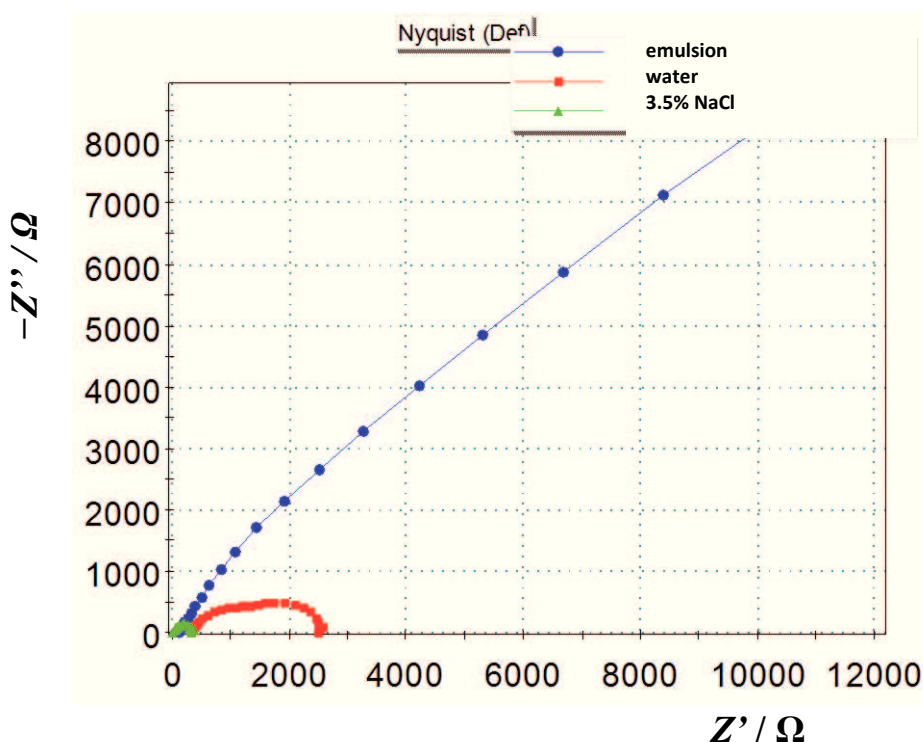
Figure 2. The comparative view of Nyquist's EIS diagrams obtained for HCTS-130 tool steel in medium of Lenox Band-Ade emulsion, water and 3.5% NaCl

From Figure 2 it can be seen that Nyquist's impedance display in the water medium and 3.5% NaCl are actually depression semicircles with a center above the real axis, which is characteristic for solid electrodes. In this respect, the charge transfer resistance  $R_{ct}$  and the double-layer capacity  $C_{dl}$  are connected parallel in the passive electrode system. The impedance measurements result in a deviation of the mentioned double-layer capacity and instead it a surface-constant phase element of the double-layer  $Q_{dl}$  introduces, which represents a combination of surface roughness properties and inhomogeneities of metal electrodes [15,16].

Lower values of charge transfer resistance in the water and 3.5% NaCl indicate that the surface of the formed oxide layer is thinner, and cannot prevent the penetration of aggressive ions from the solution, so the consequence of this is increase in the corrosion rate. Furthermore, from Table 2, it can be seen that the highest value of the surface constant phase element of the double layer  $Q_{dl}$  is recorded on the tool steel in the medium of 3.5% NaCl, indicating that the resulting passive layer growing on the surface of the tested tool steel is not enough compact in the chloride medium, due to which the capacity of the intermediate layer metal/oxide layer or inside the passive layer increases [15,16].

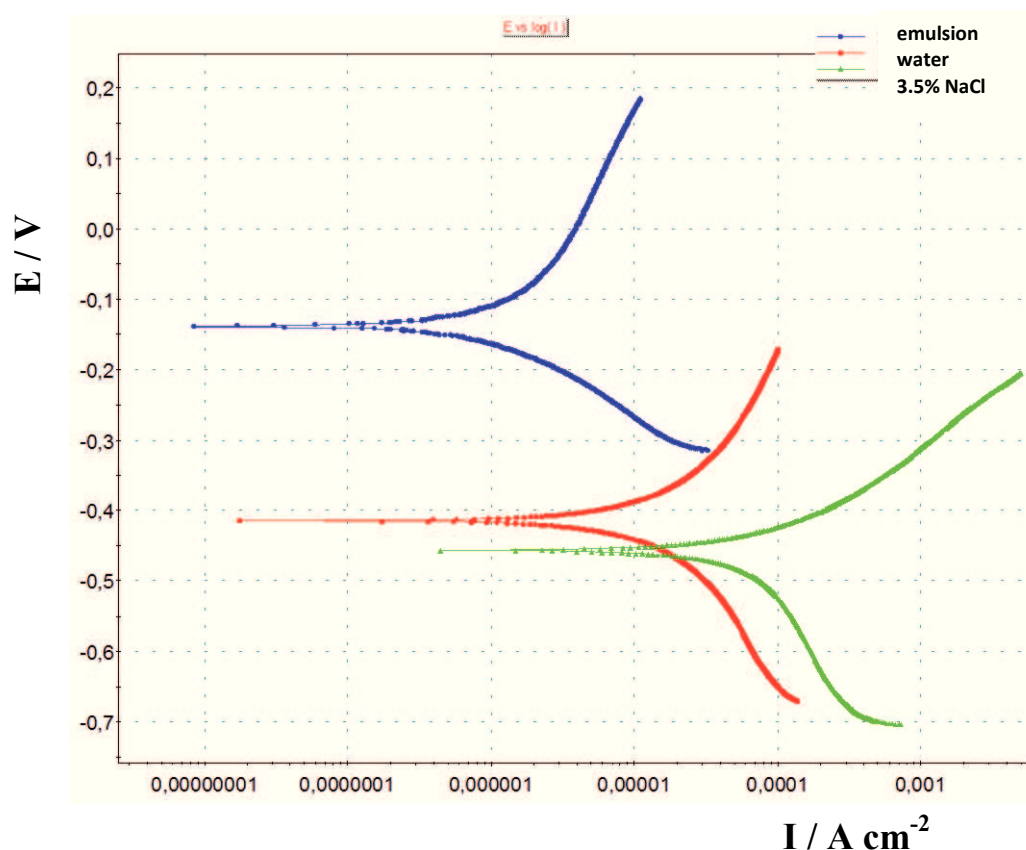
Figure 3. Polarization curves of tested tool steel obtained in medium of Lenox Band-Ade emulsion, water and 3.5% NaCl

Results obtained by electrochemical impedance spectroscopy correspond to the parameters resulting from the Tafel's extrapolation method. Potentiodynamic polarization in the range of potentials from -250 mV to +250 mV vs.  $E_{corr}$  was performed for the determination of corrosion parameters such as corrosion potential  $E_{corr}$ , corrosion rate  $v_{corr}$ , anode slope  $b_a$  and cathode slope  $b_c$ . The polarization curves of the tested tool steel sample in all three tested media are shown in Figure 3, and the obtained corrosion parameters are listed in Table 3.

From Figure 3 it can be seen that as the polarization curve is shifted to the left, the corrosion rate density and thus the corrosion rate will be smaller. Table 3 shows a very small value of corrosion rate registered for tool steel in the Lenox Band-Ade emulsion medium, while in the water and 3.5% NaCl medium a much higher corrosion rate was recorded.

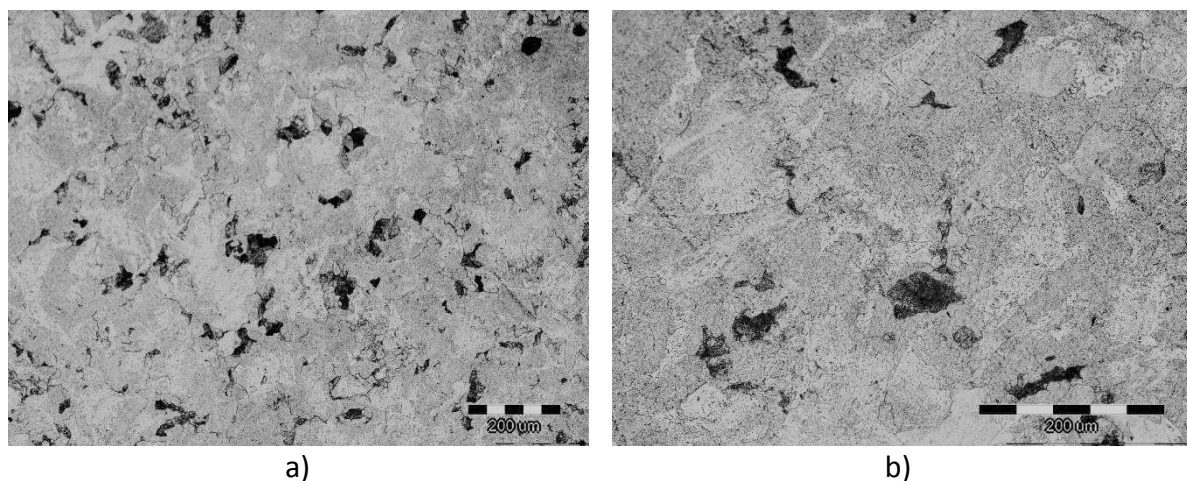
Figure 4. Microstructure of HTCS-130 tool steel for hot work after etching in Nital:  
a) magnification 100x and b) magnification 200x

Figure 4 shows that the studied tool steel has a ferrite-pearlite structure. The darker parts of the picture represent pearlite and lighter ferrite. Given the carbon content in the chemical composition, the studied tool steel belongs to the group of hypoeutectoid steel because it contains less than 0.8% C [1]. According to the chemical composition of the tested steel, it can be seen that this is a high quality steel, because the proportion of sulfur and phosphorus is low. Therefore, the surface of the examined tool steel observed "on white" was very pure, with no registered inclusions. For the purpose of observing the microstructural changes of the examined tool steel, the sample was observed using an optical microscope before and after exposure to various media (Figure 5).

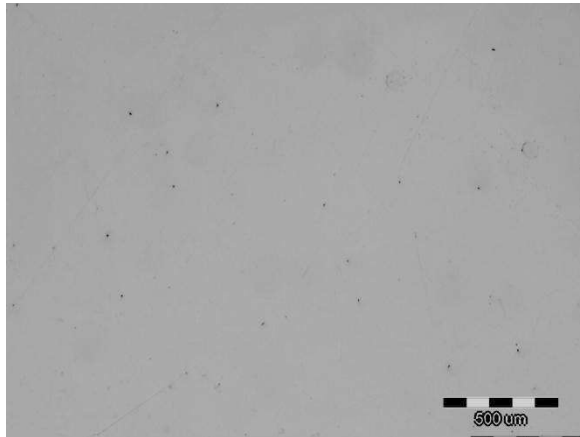
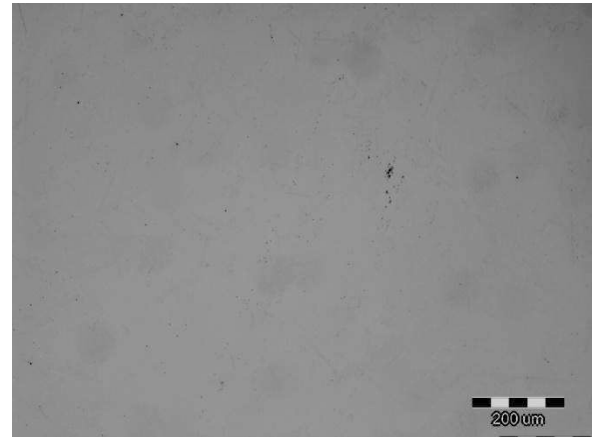
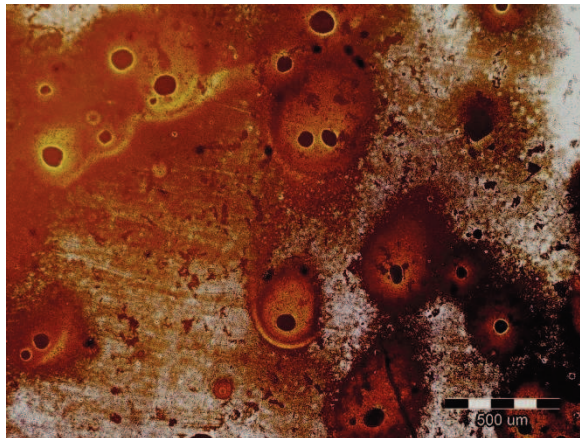
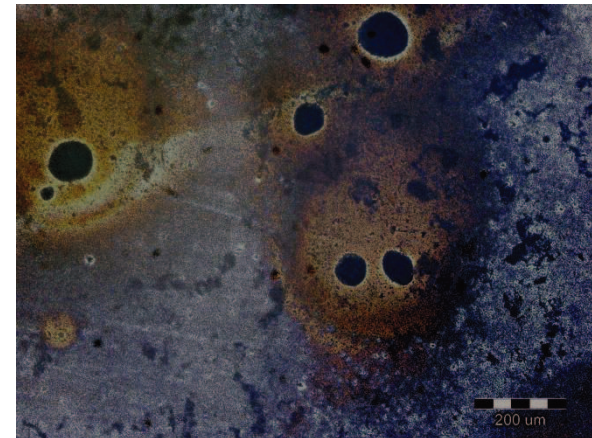
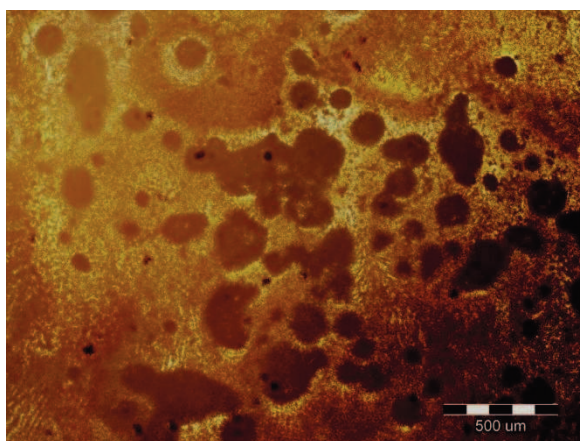
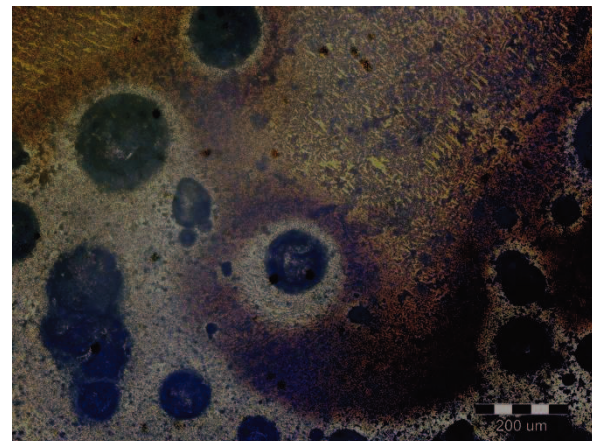
Figure 5. Microstructure of HTCS-130 tool steel for hot work in medium of Lenox Band-Ade emulsion, water and 3.5% NaCl

Figure 5 shows that the microstructure of the HTCS-130 tool steel after electrochemical testing in the Lenox Band-Ade emulsion medium remained unchanged. However, in water and 3.5% NaCl, corrosion products were deposited on the surface of the sample, which means that the mentioned media strongly attacked the metal base.

Namely, the corrosion products do not have a protective role in the corrosion process, which can be confirmed by results obtained after electrochemical measurements. It can be concluded that local corrosion takes place, i.e. pitting corrosion, because the occurred holes (pits) are characteristic for pitting corrosion. Generally, the pitting corrosion caused by the existence of large cathode and small anode surfaces, which is why the severity of attack on the anode is large. The potential difference can be caused by mechanical damage, thin coating oxide, acidic media, and corrosion due to salt, holes or cracks [18,19]. In a highly aggressive medium such as 3.5% NaCl, this kind of corrosion occurs at the destruction of the passive layer on the metal surface in the middle of the chloride action. Chloride accumulates in the destroyed pits, which encourages deeper material destruction.

Because of the aggressiveness of chloride ions, from Figure 5 it is apparent that the holes are thicker and larger on the surface of the tested sample, than in the case of water media. Therefore, by combining different alloying elements in tool steels, the aim is to achieve better corrosion resistance. Nickel increases corrosion resistance, and molybdenum with chromium increases the resistance to the occurrence of pitting corrosion. However, the low chromium and nickel content in the investigated tool steel points to the fact that insufficient corrosion resistance is ensured in the tested media.

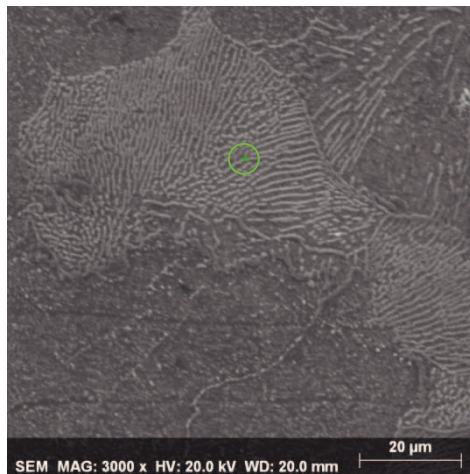
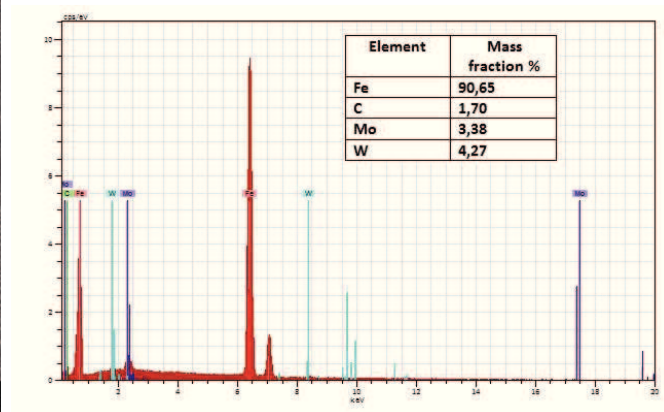
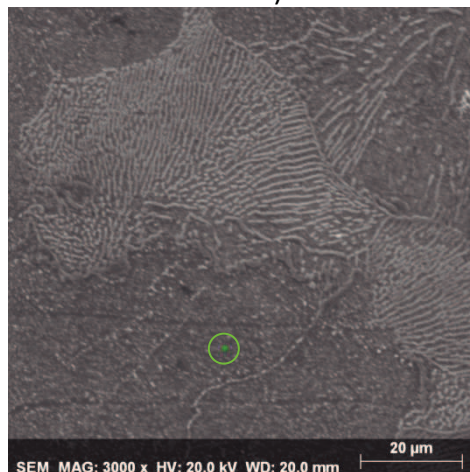
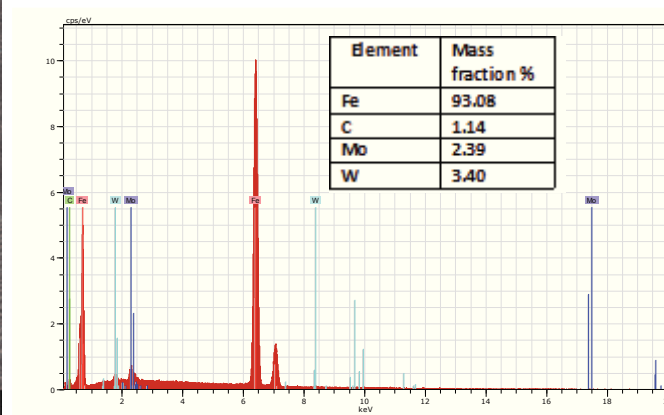
Figure 6. a) c) SEM micrographs of HTCS-130 tool steel surface after etching in Nital (magnification 3000x) and b) d) EDS analyzes

Results of testing the surface condition of the HTCS-130 tool steel conducted by scanning electron microscopy after etching in Nital are shown in Figure 6, and after the electrochemical measurements in a medium of 3.5% NaCl are shown in Figure 7.

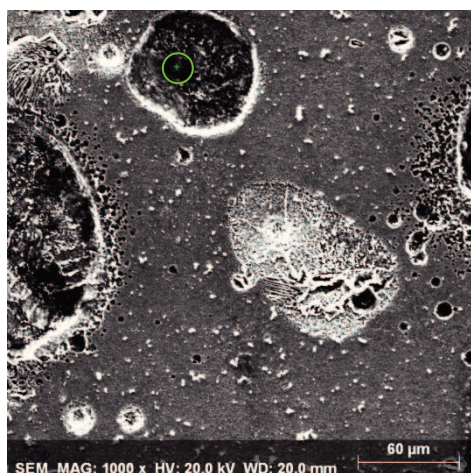
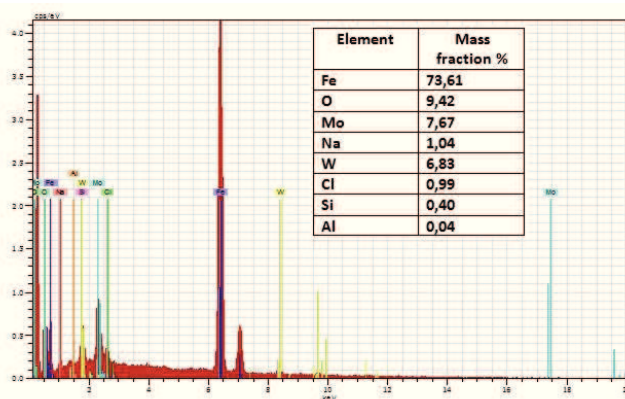
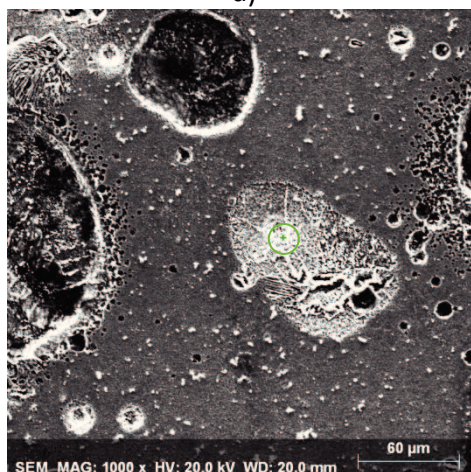
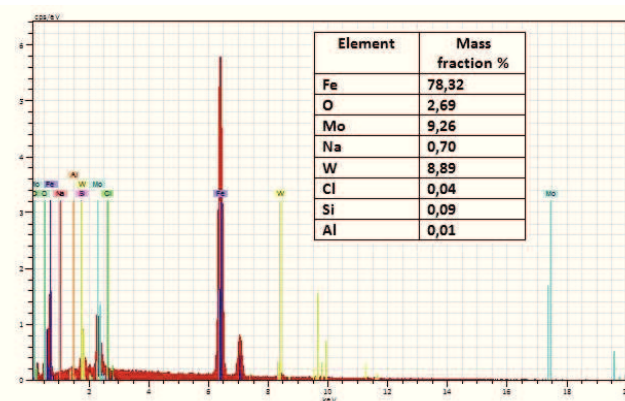
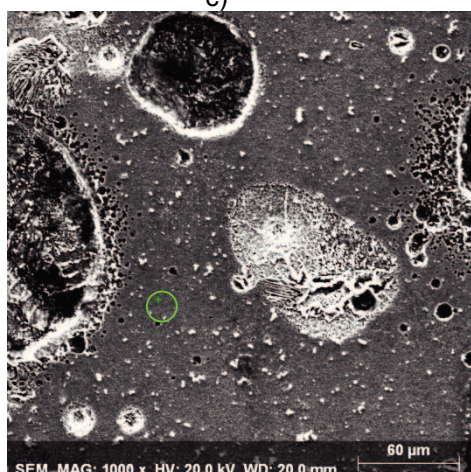
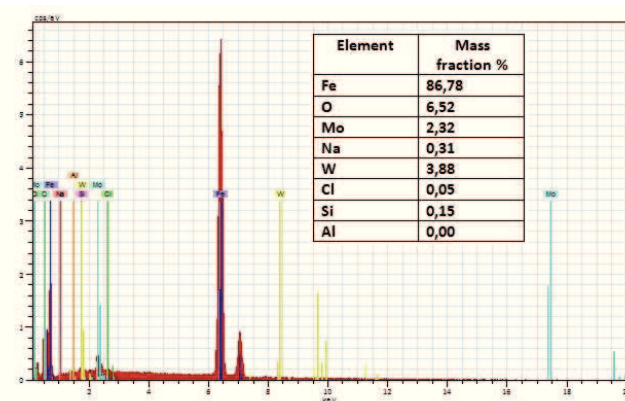
Figure 7. a),c),e) SEM micrographs of HTCS-130 tool steel surface after electrochemical measurements in the medium of 3.5 % NaCl (magnification 1000x) and b),d),f) EDS analyzes

The SEM images in Figure 7 show pitting corrosion or local corrosion caused by the breaking of the passive metal surface and can be identified by the large black holes/pits formed on the sample. The breaking of the passive layer was most likely due to the presence of chloride ions, and the additional factors that might have contributed to it were: the difference in the amount of oxygen, the pH value, the flow rate and the physical and chemical inhomogeneity of the passive layer.
