# Corrosion behavior of CuAlNiMn in 0.9% NaCl solution

Source / Izvornik: **Proceedings of 23. International Conference of Materials Protection and Industrial Finish - KORMAT 2018, 2018, 7 - 16**

## CORROSION BEHAVIOR OF CuAlNiMn ALLOY IN 0.9% NaCl SOLUTION

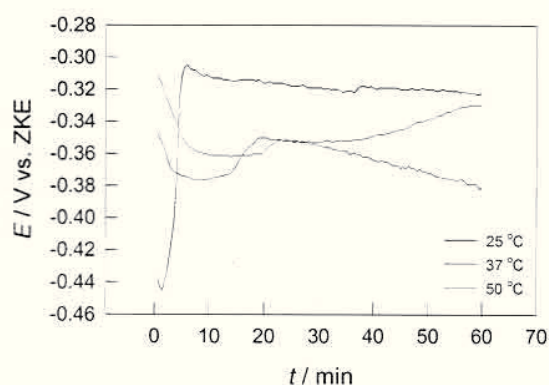
Figure 1. Variation of the open circuit potential with time for the CuAlNiMn alloy in 0.9% NaCl solution at different temperatures of electrolyte.

Figure 1 illustrates the influence of electrolyte temperature on the value of open circuit potential of CuAlNiMn alloy in 0.9 % NaCl solution at  $37$  °C, while Figure 2 shows the influence of solution pH on the value of  $E_{OC}$ .

It is apparent that the rise in electrolyte temperature leads to the changes of the  $E_{OC}$  CuAlNiMn alloy in the negative direction, which is particularly evident for the measurement at  $50$  °C. The influence of the solution pH on the value  $E_{OC}$  is shown in Figure 2. Lowering the pH values of the electrolyte leads to the negation of the open circuit potential of the CuAlNiMn alloy, which is particularly pronounced at the beginning of the measurements. Values of  $E_{OC}$  for the CuAlNiMn alloy in the NaCl solution at pH = 5.4 changes in negative direction in the first 10 minutes after the electrode immersion in the electrolyte solution, and after that have positive changes and after 60 minutes the values of  $E_{OC}$  is almost the same as the values of  $E_{OC}$  of the alloy in NaCl solution at pH = 7.4. Different behavior shows the investigated alloy in a NaCl solution at pH = 3.4, where the value of the open circuit potential changes in negative direction within the first 35 minutes of immersion in the solution and then the potential stabilization is followed by a certain fluctuation of the open circuit potential values which was not observed in the measurements at higher pH values of the solution.

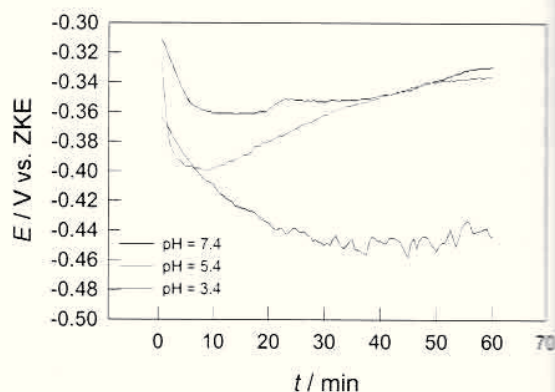
Figure 2. Variation of the open circuit potential with time for the CuAlNiMn alloy in 0.9% NaCl solution at different pH values of electrolyte.

The reason for this behaviour is probably due to the fact that at the lower pH of the NaCl solution there is a higher adsorption of chloride ions on the alloy surface, which causes higher changes of the values of open circuit potential to the negative direction, while potential fluctuations are results of the initial surface dissolution of the alloy.

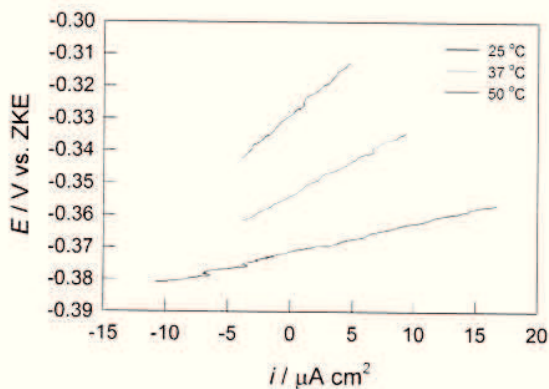
Figure 3. Results of the investigation by linear polarization method for CuAlNiMn alloy in 0.9% NaCl solution at 25 °C (-), 37 °C (-) and 50 °C (-).

The influence of the temperature on the slope of the linear parts of the polarization curves is shown in Figure 3, while the influence of the pH of the solution is shown in Figure 4.

From the Figures 3 and 4 it is apparent that elevation of the electrolyte temperature as well as lower electrolyte pH value have a negative impact on the corrosion stability of the CuAlNiMn alloy and lead to a decrease in the slope of the linear curve parts indicating a lowering the polarization resistance values.

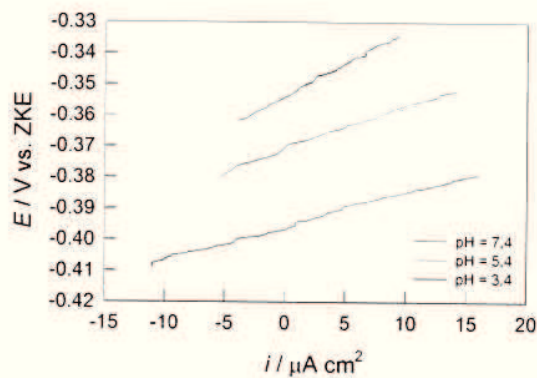
Figure 4. Results of the investigation by linear polarization method for CuAlNiMn alloy in 0.9% NaCl solution at pH = 7.4 (-), 5.4 (-) and 3.4 (-).

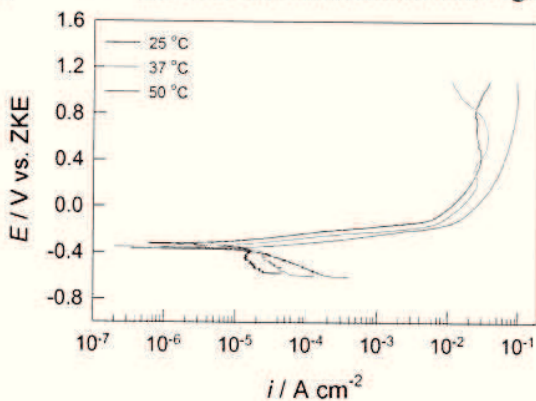
Figure 5. Potentiodynamic polarization curves for CuAlNiMn alloy in 0.9% NaCl solution at 25 °C (-), 37 °C (-) and 50 °C (-).

Potentiodynamic polarization curves were recorded in wide potential area from -250 mV vs.  $E_{OC}$  up to 1.1 V and the results are shown in Figure 5 and 6.

Figure 5 shows the influence of electrolyte temperature on the potentiodynamic polarization curve for CuAlNiMn in 0.9% NaCl solution. Increase in electrolyte temperature leads to an increase in the anodic and cathodic current density resulting in higher corrosion density, i.e. greater corrosion attack on the CuAlNiMn alloy. There is also a negative correlation of corrosion potential with an increase in electrolyte temperature.

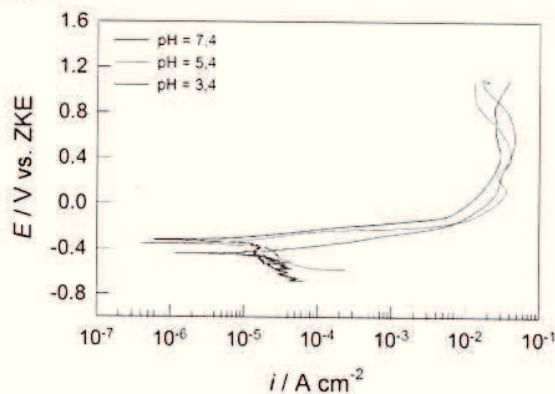
Figure 6. Potentiodynamic polarization curves for CuAlNiMn alloy in 0.9% NaCl solution at pH = 7.4 (-), 5.4 (-) and 3.4 (-).

Lowering the pH value of the electrolyte (Figure 6) greatly influences on the increase in the anodic current density and also leads to a shift of the corrosion potential to a negative direction.

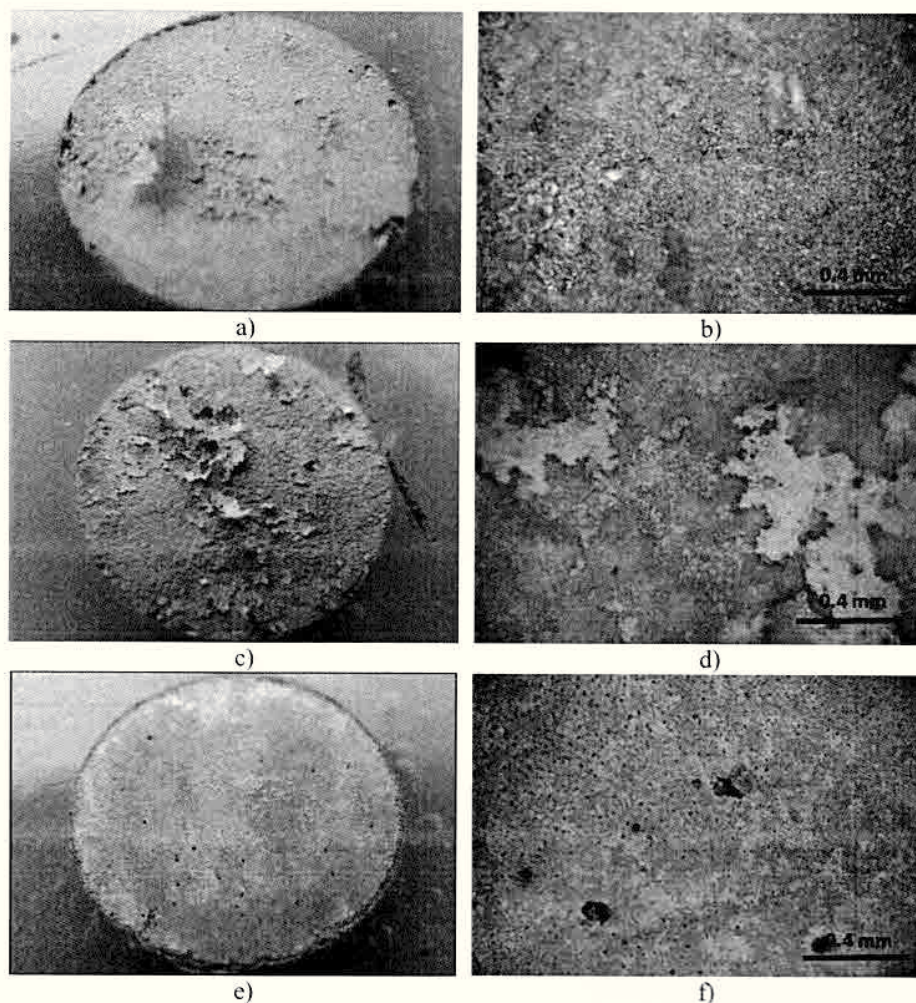
Figure 7. CuAlNiMn alloy surface images after polarization measurements 0.9% NaCl solution (pH=7.4 at different temperatures of electrolyte: a) 25 °C, macro image b) 25 °C, with magnification of 100 times, c) 37 °C, macro image d) 37 °C, with magnification of 100 times, e) 50 °C, macro image d) 50 °C, with magnification of 100 times.

After polarization measurements, the surface of the CuAlNiMn electrode was examined using light microscope, and the results of investigations have shown in Figure 7.

At macro image of the CuAlNiMn alloy surface, after polarization measurement in NaCl solution at 25 °C (Figure 7 a), significant corrosive damage is observed. There is a rupture of thin layers of corrosion products from the surface, while on the edges of the electrode there are indication of the appearance of pitting corrosion. This behaviour differs from the behaviour of the CuAlNi alloy which was investigated under the same conditions and where the dominant corrosion attack was pitting corrosion without the appearance of these poorly attached surface layers [14].

Figure 7 c) and d) shows the state of CuAlNiMn alloy surface after potentiodynamic polarization measurement in 0.9% NaCl solution at 37 °C and in Figure 7 e) and f) at 50 °C. After polarization at 37 °C, intense corrosion damages is seen on the surface of the electrode in the form of a thin leaf (exfoliation), with a large part of the surface covered with sheets of corrosion products loosely bonded to the surface which were elevated from the surface of the electrode.

After polarization measurements at 50 °C, the surface of CuAlNiMn alloy are completely hollowed out as a result of pitting corrosion (Figure 7 e) and f).

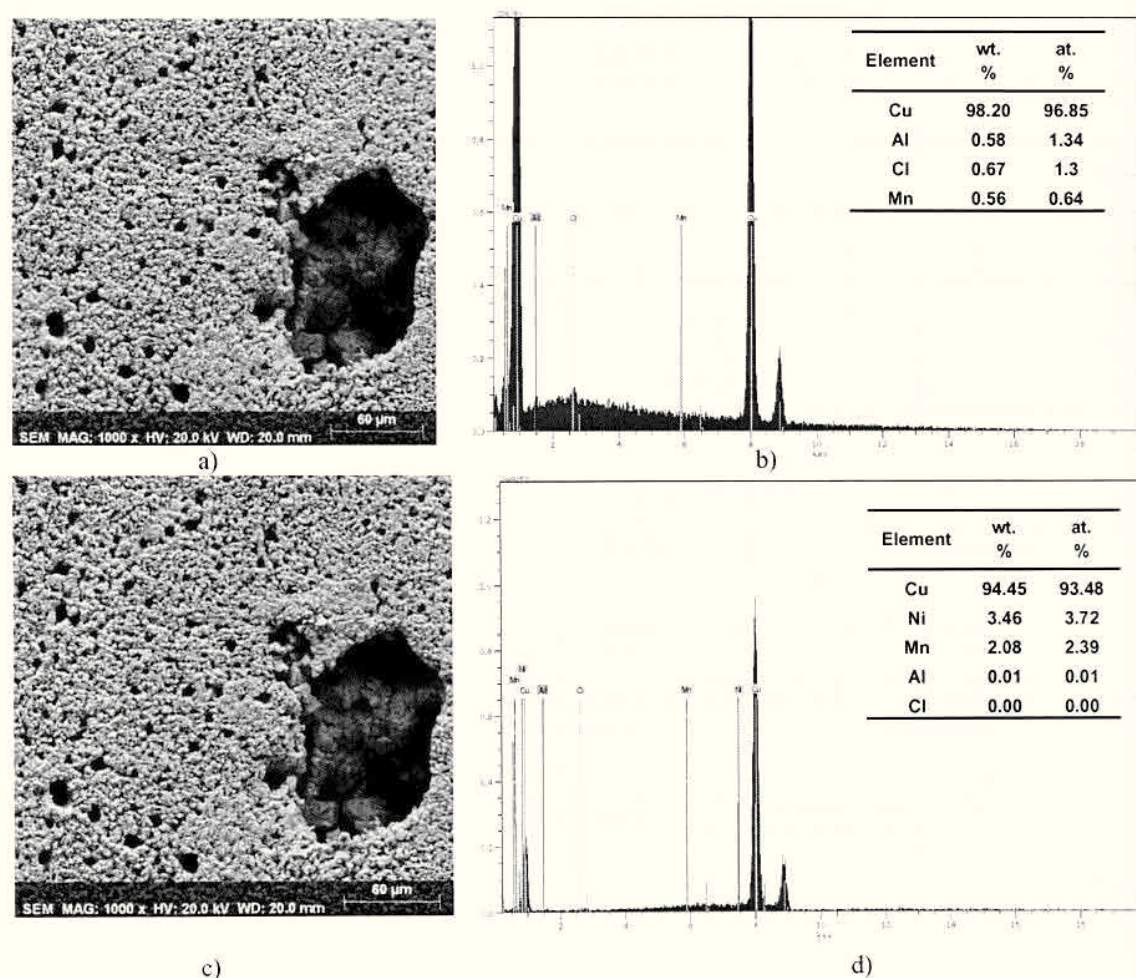
Figure 8. SEM images of CuAlNiMn alloy surface after potentiodynamic polarization in 0.9 NaCl solution (pH = 7.4 and T = 50 °C) with magnification of 1000 times a) and c) along with EDS surface analysis b) i d).

More detailed information on the surface condition of the samples was given by the SEM / EDS analysis, the results of which are shown in Figure 8 a)-d). Figure 8 shows the surface of CuAlNiMn alloy after potentiodynamic polarization measurement in a 0.9% NaCl solution at 50 °C.

Two layers of corrosion products are visible on the electrode surface, porous outer surface layer and also highly damage interior layer. The elemental composition of the surface layer shows the dominant element Cu along with the detected presence small amount of Al, Mn and Cl.

The elemental analysis of the inner surface layer revealed the presence of small quantities of Ni which is not detected in the outer surface layer. Also, the percentage of Mn is higher and the percentages of Al lower than in outer surface layer.

Unlike CuAlNi electrodes, where surface layers of corrosive products emerged in the form of raised "spikes" beneath which there were pits [15], the investigated CuAlNiMn alloy showed much greater corrosion destruction of the surface. These observations are contradicted by the literature findings in which alloying CuAlNi alloys with elements such as Mn or Ti leads to improved mechanical properties of the alloy and increases their corrosion resistance [6]. Some studies [6] have found that the addition of Mn as an alloying element to CuAlNi alloy in the amount up to 0.7% leads to the increased corrosion resistance of the alloy due to the reduction of the grain size in the material as well as the increase in the stability of the passive film on the alloy surface. However, further increase in Mn content in the alloy increases the grain size and reduces corrosion resistance. Since the content of Mn in the investigated alloy is relatively high (2.5%), this could be one of the reasons for the worsening of corrosion resistance due to grain size growth.
