# Corrosion behavior of CuAlNiMn in 0.9% NaCl solution

Source / Izvornik: **Proceedings of 23. International Conference of Materials Protection and Industrial Finish - KORMAT 2018, 2018, 7 - 16**

## CORROSION BEHAVIOR OF CuAlNiMn ALLOY IN 0.9% NaCl SOLUTION

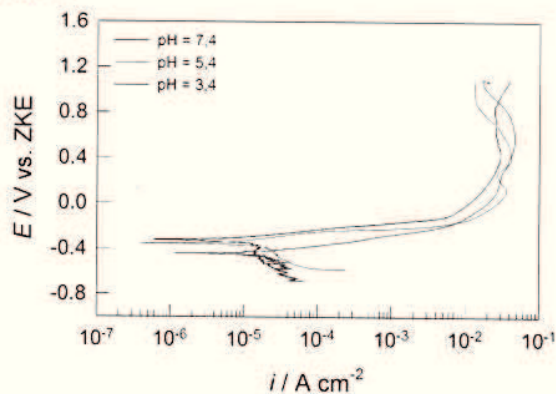
Figure 6. Potentiodynamic polarization curves for CuAlNiMn alloy in 0.9% NaCl solution at pH = 7.4 (-), 5.4 (-) and 3.4 (-).

Potentiodynamic polarization curves were recorded in wide potential area from -250 mV vs.  $E_{OC}$  up to 1.1 V and the results are shown in Figure 5 and 6.

Lowering the pH value of the electrolyte (Figure 6) greatly influences on the increase in the anodic current density and also leads to a shift of the corrosion potential to a negative direction.
