# Analysis of the crack formation in ASIS M2 high-speed tool steel during utilization

Source / Izvornik: **Proceedings book of 19th International Foundrymen Conference, 2021**

### ANALYSIS OF THE CRACK FORMATION IN ASIS M2 HIGH-SPEED TOOL STEEL DURING UTILIZATION

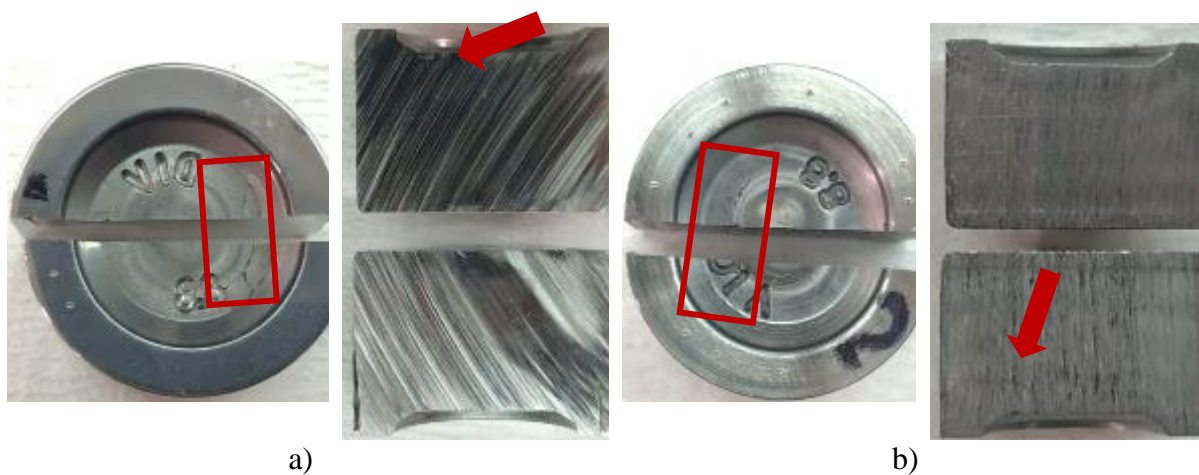
Figure 1. Sampling for metallographic analysis: a) sample 1, b) sample 2

In both samples' cracks can be observed on the tools' surface at the sharp transition between the outer edge and the contact surface (Figure 1). When marking the screw, the outer edge of the tool serves to position and hold the screw while the contact surface marks the screw's head. Cracks in sample 1 occurred after 50.000 punched marks while in sample 2 they occurred after 20.000 punched marks.

The sampling was performed perpendicular to the cracks' propagation direction (Figure 1). The samples were etched after standard metallographic preparation comprehending grinding and polishing. Two different solutions were used for etching:

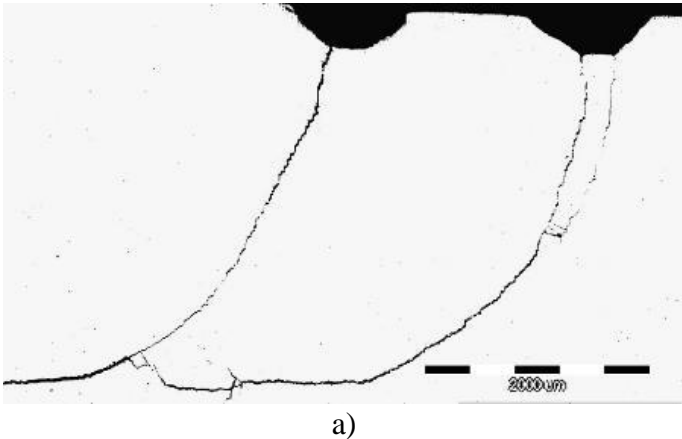
Figure 5. The MIA of the sample 2 in: a) polished, b) etched condition

In contrary to the sample 1, the cracks in sample 2 show a greater tendency towards branching and material layering (Figure 5 a). Due to the energy dissipation, the crack propagation in the sample 2 is not as deep as in sample 1. Apart from the crack, there are no other visible defects in the macrostructure of sample 2. Etching of the sample revealed a texture affecting the crack propagation direction. No other heterogeneities are observed in the macrostructure of the sample 2 (Figure 5 b).
